IODP EXP 358 Daily Geomechanics Report

Report #033 20181212 Final 5230

Site Name:	C0002	Hole Name:	Q
Water Depth:	1,939.0 m	RT-MSL:	28.5 m
Current Depth:	4928 (4926) 5230.0(5227.0) mBRT(mTVD)	Section TD:	5,667.5 (5,664.5) mBRT mTVD
Section #:	1	CSG Depth/Size:	(4855.0) 11-3/4 mBRT
Static MW:	1.37 sg	Current ECD:	1.41 sg
FIT/LOT/ XLOT:	FIT maximum pressure = 1.45 sg, Possible "LOP" = 1.43 sg @4855 mBRT		
Current formation/ lithology:	Shale		
Sensor Offsets from the Bit:	arcVISION 675: (APWD: 3.71 m, Resistivity: 4.42 m, GR: 4.47 m) TeleScope 675: (Direction + Inclination: 11.94 m)		
Other BHA Offsets from the Bit	8-1/4" Stabilizer: 17.50~19.09 m 8-1/4" x 12-1/4" Z-reamer: 28.51~29.86 m 8-1/8" Stabilizer: 40.04~41.70 m 3 x 8-1/2" Drill Collar: 137.07~164.42 m 10-5/8" Stabilizer: 164.42~165.39 m 6 x 8-1/2" Drill Collar + Jar: 165.3~229.99 m Top of BHA: 343.46 m		
Current Operations:	Pulled back to kick off point to underream the sidetrack of preference (smaller dogleg). Dropped ball to active 12-1/4" underreamer. Washed down to 4920 mMDRT where increase in ECD was observed. Pulled off bottom and ECD returned to nominal pressure. Return to drilling where by increased ECD and SPP cont

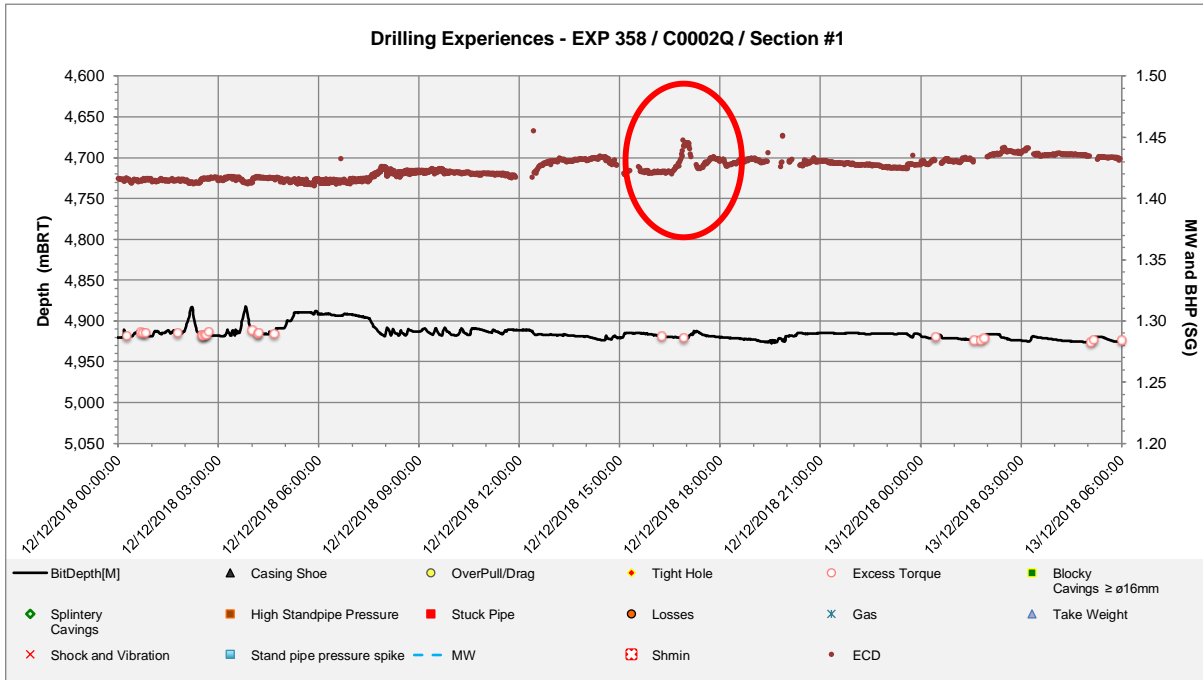
Figure 2 Drilling Experiences over the last 24hrs

The last 24hrs have been spent washing and reaming down the “QA well”. At 17:40 on the 12th Dec ECD increased rapidly (Figure 2 red circle), after which hole cleaning has been the focus.

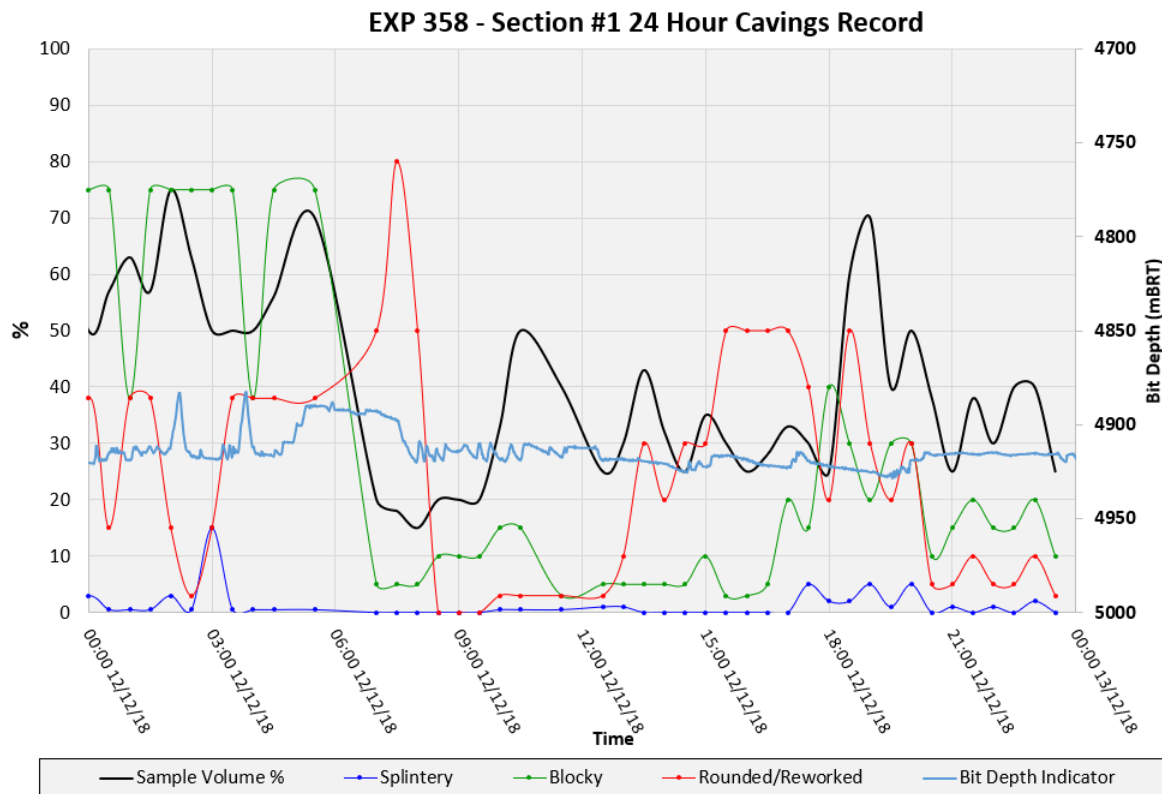
Figure 3 Analysis of cuttings/cavings > ϕ 4mm (taken from 400cc RTG Samples) over last 24hrs

The amount of cuttings/cavings > ϕ 4mm per unit volume was high at ~70%, with the majority of the samples were fresh block/angular, with reworked blocky angular consisting of ~10-30%, increasing in proportion to decreasing volume of fresh blocky cuttings.

The presence of fresh platy cavings continued, likely the result of mechanical damage to the formation from reaming / wiping over the same interval for ~48hrs (4,885 to 4,920mBRT)

The increase in the volume of cement further confirms that the BHA is in the "QA well", as the volume of cement at TD of the "QB well" was trace. The volume of cement at the shakers continues to be 0-10% with many large (>30mm), rounded cement blocks coming to the shakers. The rounded shape indicates the cement blocks were generated while milling the window.

The large blocks of cement (~3cm diameter) occur at the shakers indicating that the hole cleaning is capable of lifting large cavings, in the event that extreme hole cleaning is needed.

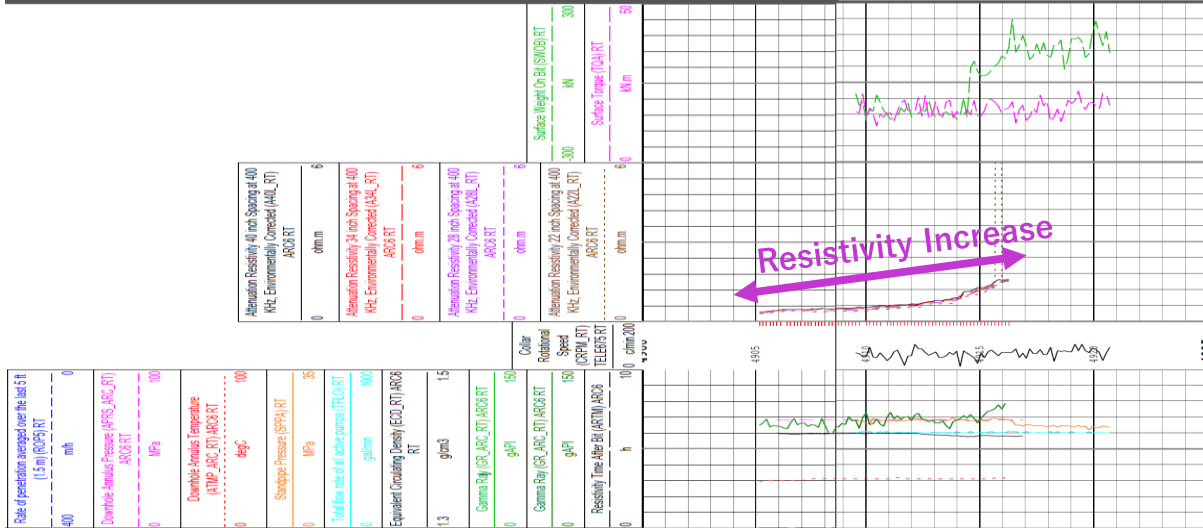
Figure 4 Section #1 Run #5 arcVISION Resistivity increase

RT resistivity increases rapidly over the interval of 4,912-4916mBRT (4,916-4,920mBRT bit depth) from 0.5ohm.m to 2.5ohm.m (Figure 4), showing a very different profile compared to the resistivity log from C0002P at these depths (Figure 5).

- The BHA is passing from an overgauge hole into a gauge hole
- It's possible cuttings are accumulating in overgauge hole due to insufficient annular velocity, as APWD sensor passes into overgauge hole the ECD ↑
