IODP EXP 358 Daily Geomechanics Report

Report #036 20181215

Site Name:	C0002	Hole Name:	Q
Water Depth:	1,939.0 m	RT-MSL:	28.5 m
Current Depth:	No bit in hole mBRT (mTVD)	Section TD:	5,667.5 mBRT (5,664.5) (mTVD)
Section #:	1	CSG Depth/Size:	(4855.0) 11-3/4 mBRT
Static MW:	1.37 sg	Current ECD:	1.41 sg
FIT/LOT/ XLOT:	FIT maximum pressure = 1.45 sg, Possible "LOP" = 1.43 sg @4855 mBRT		
Current formation/ lithology:	Shale		
Sensor Offsets from the Bit:	N/A		
Other BHA Offsets from the Bit	N/A		
Current Operations:	Rigged up wireline. Made up 11-3/4" EZSV to plug setting tool and RIH on wireline to setting depth. Commenced depth correlation.

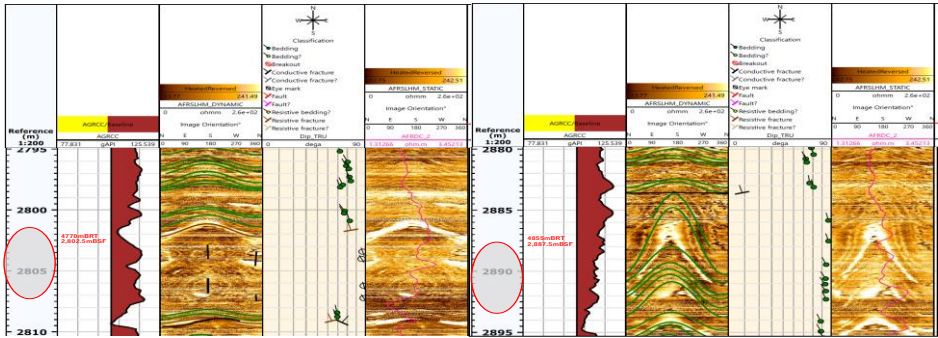
Fracture Gradient	N/A
Pore Pressure	No significant gas peaks or other indications of overpressure observed.
Wellbore Breakout	N/A
Tensile Failure	N/A
Drilling Parameters	N/A
Other	<p>Based on AFR image collected in C2P hole (Figure 1), a comparison between bedding at the window setting depths indicate C2Q would have encountered beds dipping $\sim 85^\circ$ to the NNW, while the C2R planned window is likely to encounter beds dipping 60°-70° to the NNW.</p> <ul style="list-style-type: none"> – Both bedding plane geometries are vulnerable to anisotropic bedding plane failure. – Both window setting depths likely experienced anisotropic failure during Exp 348 due to inadequate MW and mechanically-induced hole damage from numerous pack-off events. It is unlikely the hole is in pristine condition and may contain cement in the annulus with clasts of well-rounded blocky cavings from Exp 348. – The cement at the C2R window may or may not have been damaged during C2Q operations. <p>Note: High-resolution repeat passes of the AFR image tool did not occur across the two window depths; however, repeat passes below the window depths indicated substantial anisotropic failure. We would expect similar failure at the window depths since bedding planes are suitable for failure and they experienced pack-off events.</p>

<p style="text-align: center;">Figure 1 Proposed C002Q v Actual C002P whipstock setting depths *Windows represented by grey circles on depth track</p>
