# IODP EXP 358 Daily Geomechanics Report

Report #051 20181230

Site Name:	C0002	Hole Name:	R
Water Depth:	1,939.0 m	RT-MSL:	28.5 m
0600h Depth:	4,963.0 mBRT (4,961.0) (mTVD)	Section TD:	5,667.5 mBRT (5,664.5) (mTVD)
Section #:	0	CSG Depth/Size:	4757.0 mBRT 11-3/4 inches
Static MW:	1.39 sg	Current ECD:	(1.41) sg
FIT/LOT/ XLOT:	1.46sg FIT @ 4,757mBRT.		
Current formation/ lithology:	Shale		
Sensor Offsets from the Bit:	TeleScope 675: (Direction + Inclination: 18.00 m)		
Other BHA Offsets from the Bit:	8-1/2" Mill Tool Bit: 0~0.24 m Motor with 1.5 deg bend: 0.24~8.09 m 8.125" Stabilizer: 8.09~9.76 m 2 x 6-3/4" Non-Magnetic Drill Collar + TeleScope 675: 10.54~32.21 m 9 x 6-3/4" Drill Collar: 32.21~116.80 m 6-1/2" Hydraulic Jar: 116.80~126.73 m 2 x 6-3/4" Drill Collar: 127.73~145.39 m 12 x 5.68" Heavy Weight Drill Pipe: 146.19~257.14 m Top of BHA: 258.14 m		
Current Operations:	RIH with 8-1/2 " kick off assembly. Performed a slip and cut on the way. Commenced washing and then reaming down at 2:00 Dec.31. 4963 mBRT (bit depth) as of 06:00 Dec.31.

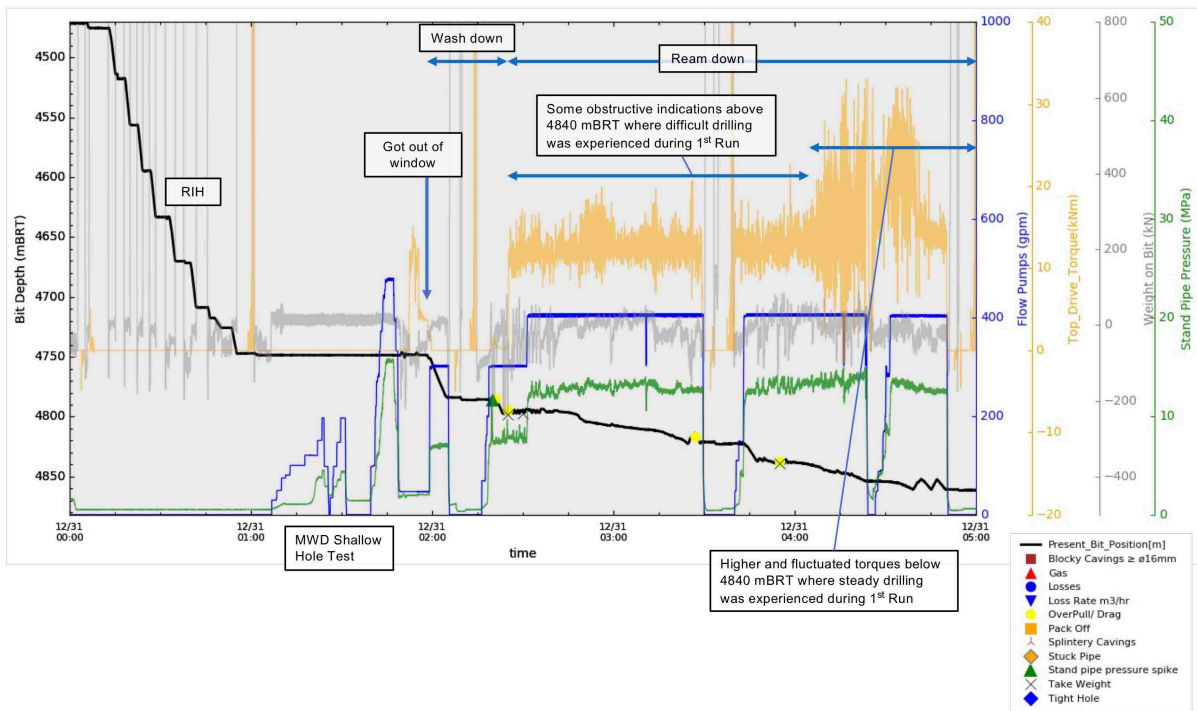
Some obstructive indications were observed while washing and reaming down from the window to 4840 mBRT where difficult drilling was experienced during the 1<sup>st</sup> kick-off run. Enlarged and distorted hole shape is expected in this interval. Below 4840 mBRT where steady drilling was performed, higher and fluctuated torques became marked. Time-dependent hole deterioration may have been progressed to some extent below 4840 mBRT during the past 24 hours. However, no other evidence has been seen to suggest hole deterioration.

**Figure 1:** Drilling experiences over the last 5 hrs (~05:00 Dec.31).

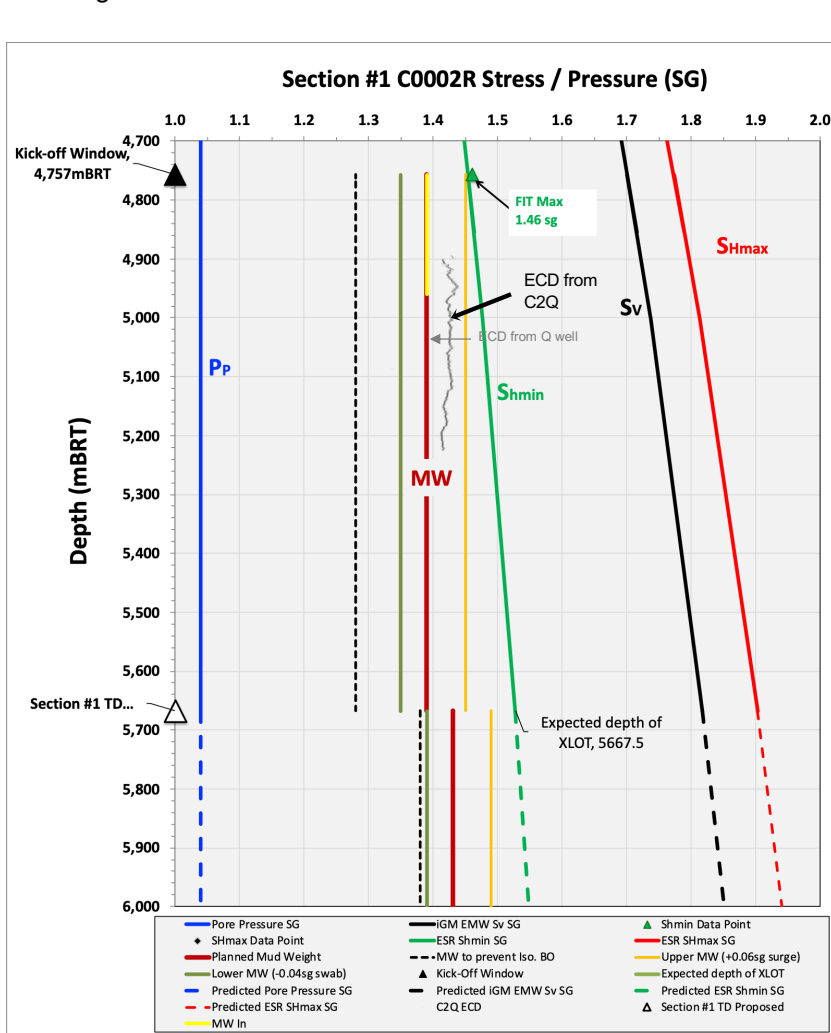
No change in the current stress model.

Figure 2: Current stress model for Section #1

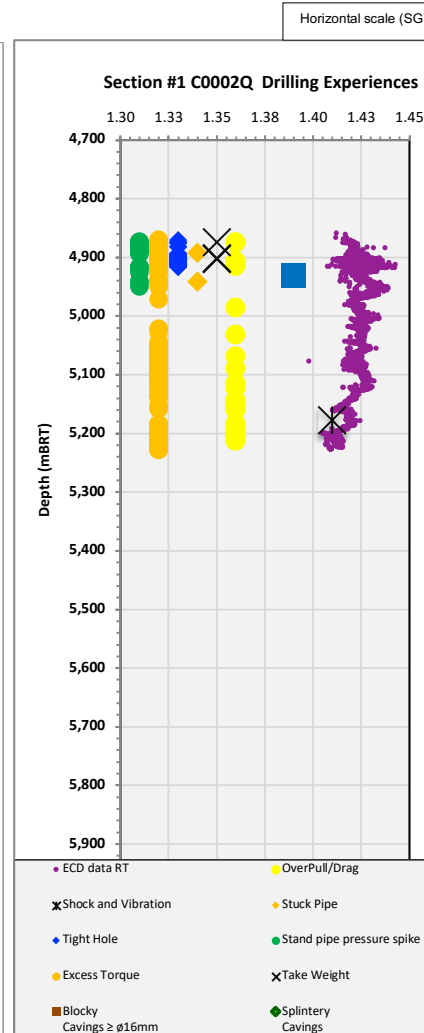
Figure 3: C0002Q Drilling Experiences

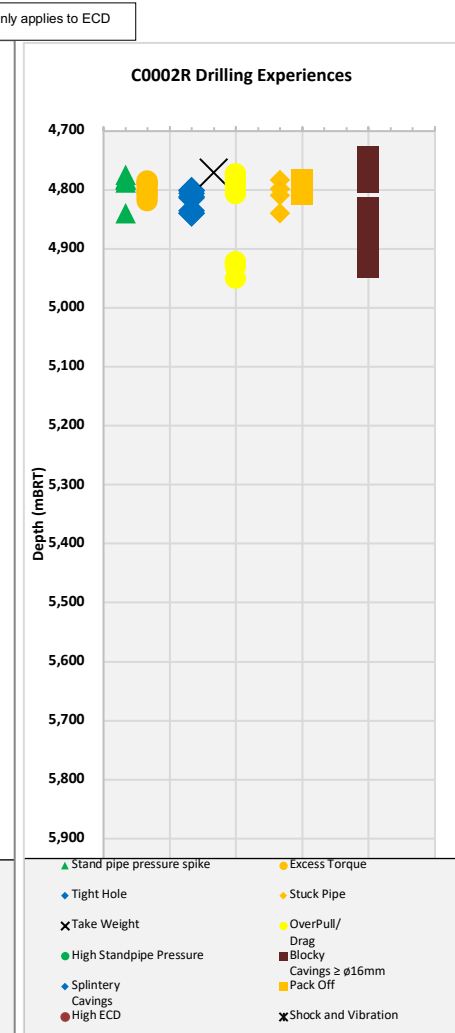
Figure 4: C0002R Drilling Experiences
