IODP EXP 358 Daily Geomechanics Report

Report #054a 20190102

Site Name:	C0002	Hole Name:	R
Water Depth:	1,939.0 m	RT-MSL:	28.5 m
0600h Depth:	5,052.0 mBRT (5049.0) (mTVD)	Section TD:	5,667.5 mBRT (5,664.5) (mTVD)
Section #:	0	CSG Depth/Size:	4757.0 mBRT 11-3/4 inches
Static MW:	1.39 sg	Current ECD:	(1.41) sg
FIT/LOT/ XLOT:	1.46sg FIT @ 4,757mBRT.		
Current formation/ lithology:	Shale		
Sensor Offsets from the Bit:	TeleScope 675: (Direction + Inclination: 18.00 m)		
Other BHA Offsets from the Bit:	8-1/2" Mill Tool Bit: 0~0.24 m Motor with 1.5 deg bend: 0.24~8.09 m 8.125" Stabilizer: 8.09~9.76 m 2 x 6-3/4" Non-Magnetic Drill Collar + TeleScope 675: 10.54~32.21 m 9 x 6-3/4" Drill Collar: 32.21~116.80 m 6-1/2" Hydraulic Jar: 116.80~126.73 m 2 x 6-3/4" Drill Collar: 127.73~145.39 m 12 x 5.68" Heavy Weight Drill Pipe: 146.19~257.14 m Top of BHA: 258.14 m		
Current Operations:	Continued drilling the 8-1/2" hole with a combination of rotary and sliding drilling to 5052 mBRT. After reaching TD, performed circulation and bottoms up for 3 hours and then wiper trip. 4974.5 mBRT (bit depth) as of 06:00 Jan.3 rd .

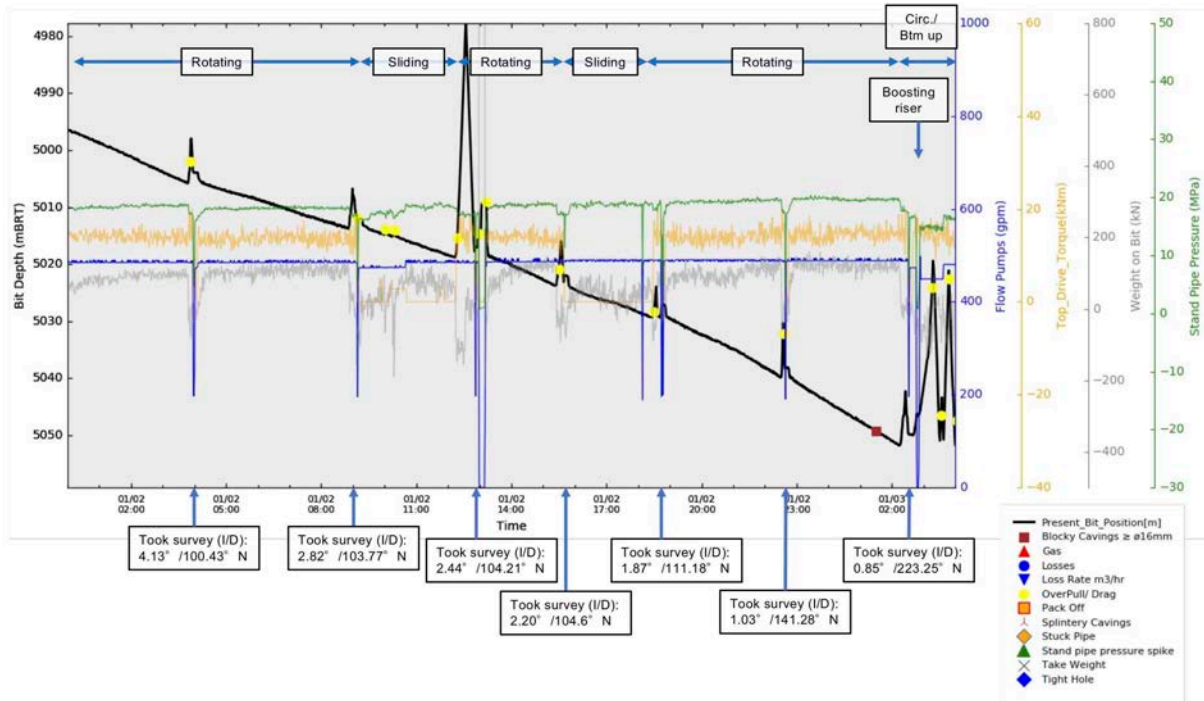
Drilled ahead from 4996.5 mBRT with a combination of rotary drilling and sliding. Multiple overpull/drag events occurred while picking up BHA to record survey's. No adverse conditions occurred while drilling or sliding.

Figure 1: Drilling experiences over the last 28 hrs (~04:00 Jan. 3).

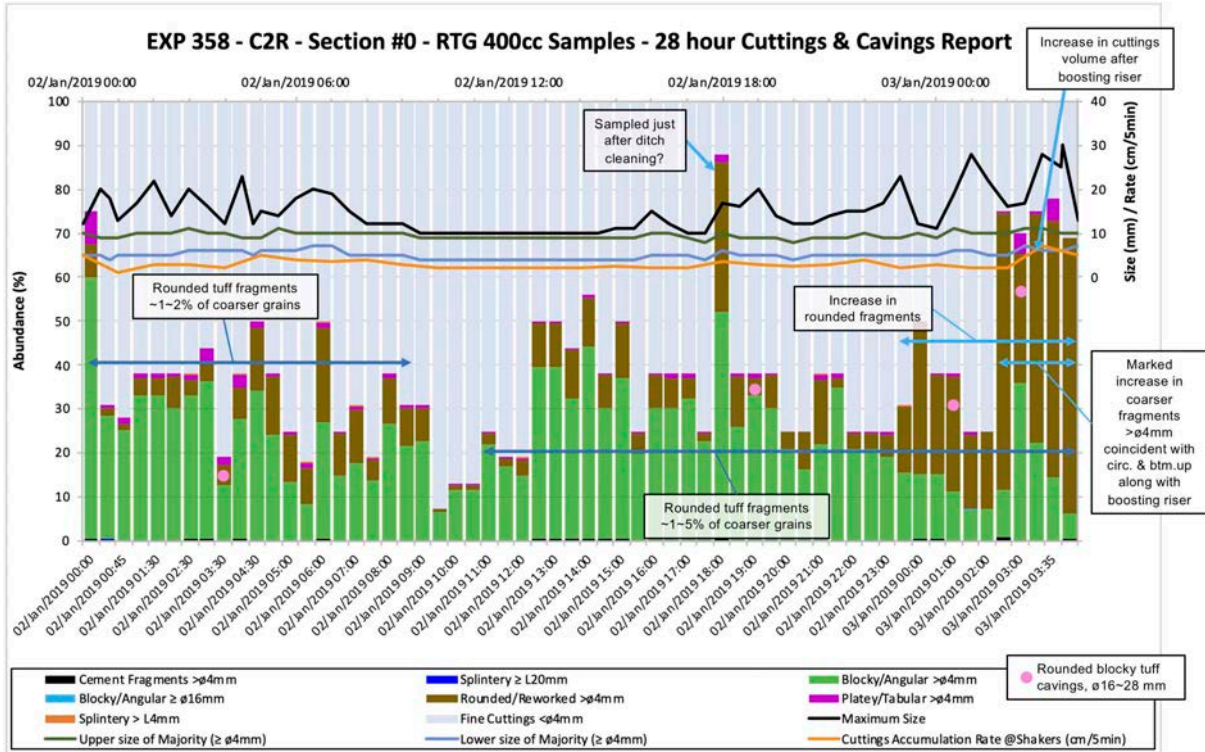
Coarser shale/mudstone fragments > ϕ 4mm with sharp edges were typically blocky with minor occurrence of platy fragments dominated the cuttings populations down to 5032.5 mBRT lag depth. Samples approximately $\sim\phi$ 10 mm likely reflect cuttings created by the tri-cone bit. No obvious indications of wellbore instability were seen in the shale/mudstone fragments that could not be explained by the tri-cone bit cutters. Tuff fragments with generally rounded shapes remain present throughout; however, proportion in coarser grains $\geq \phi$ 4mm are \sim 1~2 % in most samples. Occurrence of large tuff fragments (ϕ 16~28 mm) were rare, but remains occasionally present until reaching TD. These tuff fragments may be fresh blocky cavings derived from tuff layers within the 4840-4843 mBRT interval or tuff layers elsewhere. It is possible that the weak boundaries between the tuff and claystone/siltstone are inducing small scale and local anisotropic failure.

Figure 2: Analysis of cuttings/cavings > ø 4mm (taken from 400cc RTG Samples) over last 28 hrs (~04:00 Jan.3). Not corrected for lag-time. The marked increase in rounded cuttings after 0230 hrs is likely due to cuttings that were trapped in the riser and released after increasing the riser flow rate to ~900 gpm (boosting riser). The increase in rounded blocky cuttings at 2330 hrs indicate cuttings that have not been removed in the hole cleaning process.

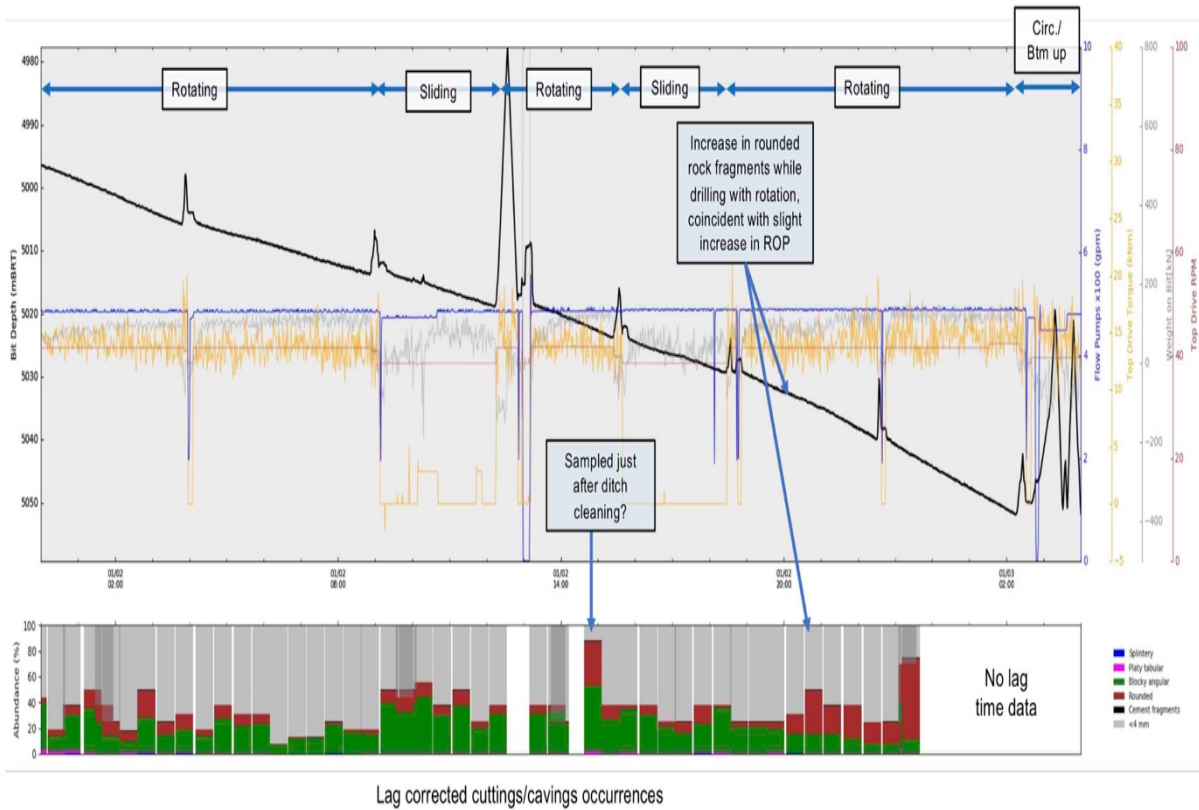
Figure 3. Correlation between drilling events and lag corrected cuttings/cavings occurrences over last 24 hrs (00:00~24:00 Jan.2). This increase in rounded cuttings at 2000 hrs and again at 2300 hrs may indicate that current hole cleaning practices at ~480 gpm were being hampered. If cuttings are being trapped around the drill-pipe or seated on breakout ledges, pipe movement while taking surveys may have stirred these up.

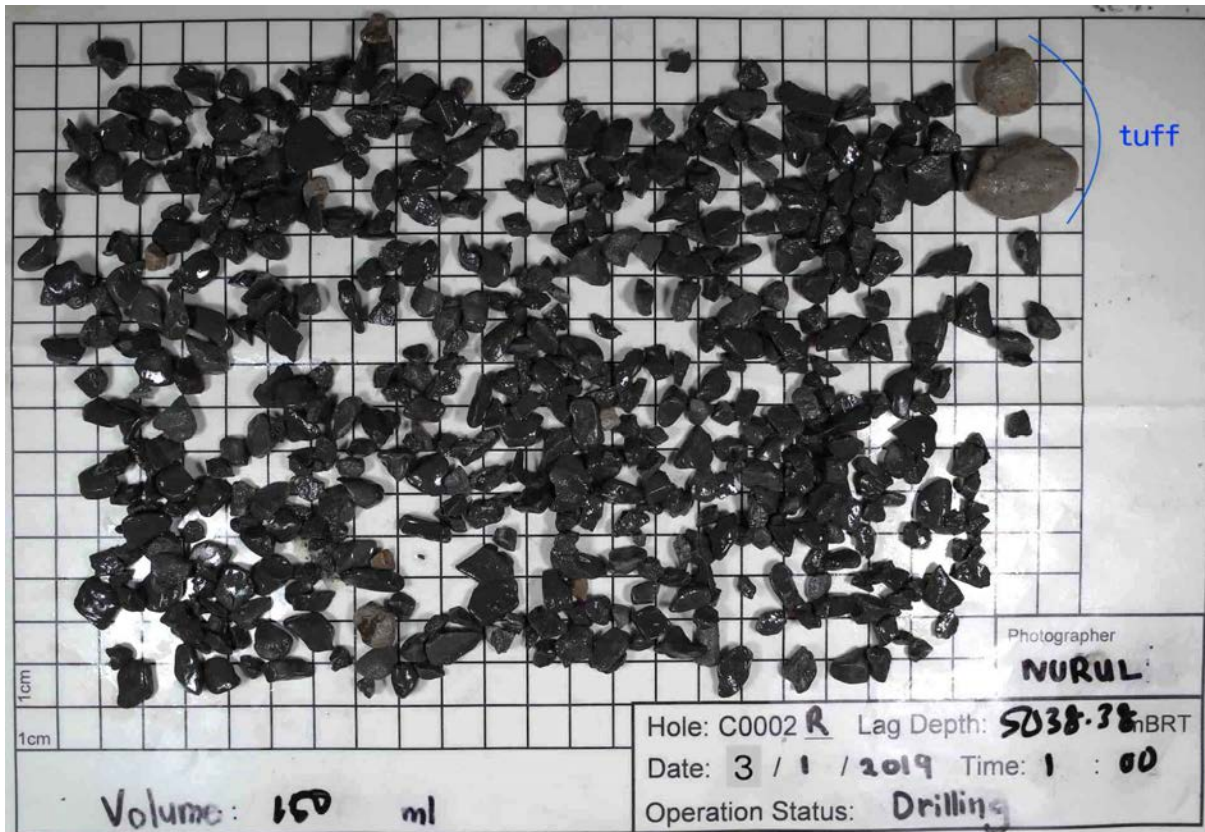
Figure 4: Example of cuttings/cavings > \varnothing 4mm (taken from 400cc RTG Samples). This sample is predominantly rounded shale fragments $\leq \varnothing$ 10 mm, associated with rounded large blocky tuff cavings.

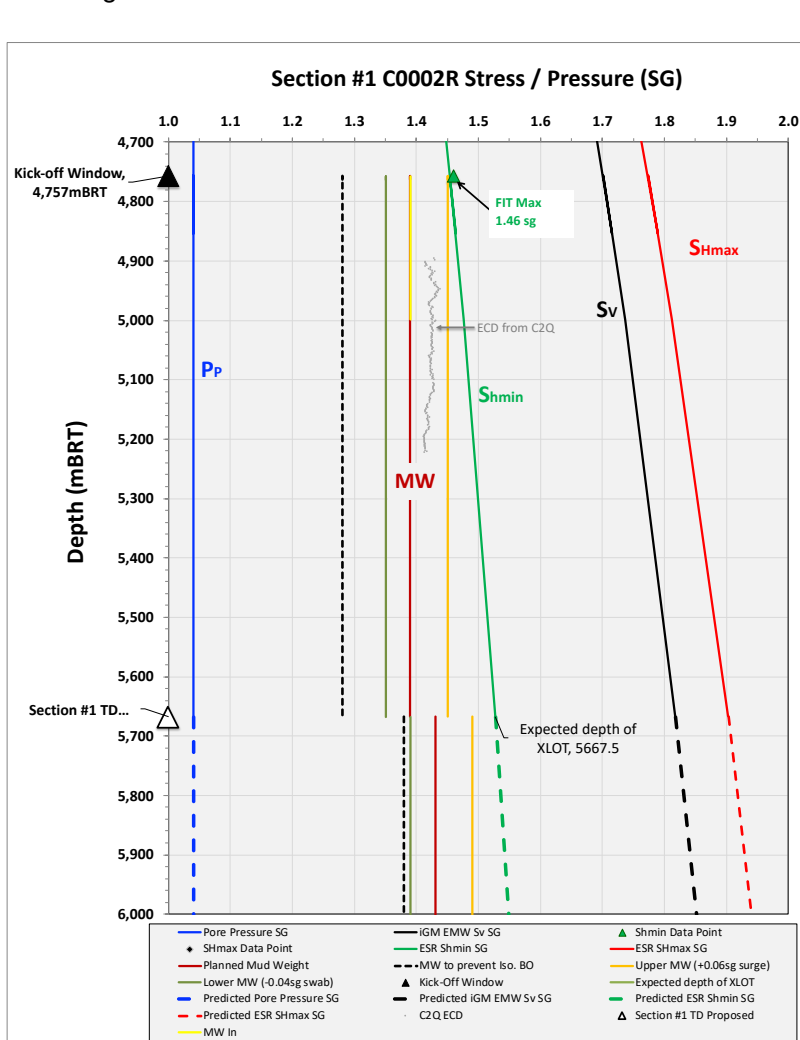
Figure 5: Current stress model for Section #1

No change in the current stress model.
