IODP EXP 358 Daily Geomechanics Report

Report #061 20190109

Site Name:	C0002	Hole Name:	R
Water Depth:	1,939.0 m	RT-MSL:	28.5 m
0600h Hole Depth:	5,052.0 mBRT (5049.0 mTVD)	Section TD:	5,667.5 mBRT (5,664.5 mTVD)
Section #:	1	CSG Depth/Size:	4757.0 mBRT 11-3/4" inches
Static MW:	1.39 sg	Current ECD:	sg
FIT/LOT/ XLOT:	1.46sg FIT @ 4,757mBRT.		
Current formation/ lithology:	Shale		
Sensor Offsets from the Bit:	arcVISION 675: (APWD: 6.919 m, Resistivity: 7.631 m, GR: 7.682 m) TeleScope 675: (IWOB: 11.699m, Direction + Inclination: 16.064 m) <i>*Note arcVISION and TeleScope are behind 12-1/4" HRR Underreamer</i>		
Other BHA Offsets from the Bit:	8-1/4" x 12-1/4" HRR-8000 reamer: 1.46 m 10-5/8" Stabilizer: 21.771 m Top of BHA: 341 m		
Current Operations:	POOH and lay down 8-1/2" x 12-1/4" LWD BHA (BHA #20). Rigged up and ran in hole with 8-1/2" x 12-1/4" LWD BHA (BHA #21) to 530mBRT.

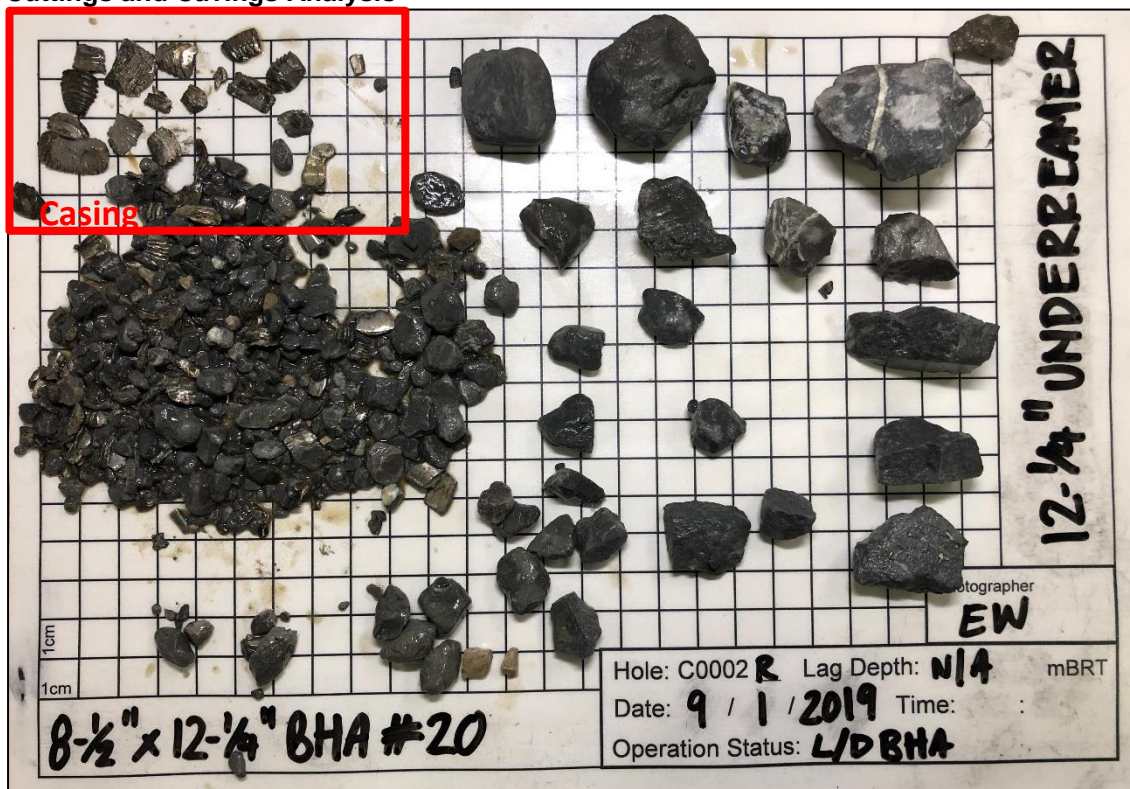
Figure 1 Sample from BHA #20 12-1/4" Underreamer

Large blocky cavings were recovered from the 12-1/4" underreamer.

- Large blocks in the top middle of Figure 2 are rounded and appear to be consistent with the claystone and siltstone implying that the material between the tuff is beginning to show more failure than previous passes. The large and angular shape of the blocky casings imply the failure occurred during the previous BHA run. Metal material is from somewhere in the casing section; possibly from the edges of the window.
