IODP EXP 358 Daily Geomechanics Report

Report #063 20190111

Well Status

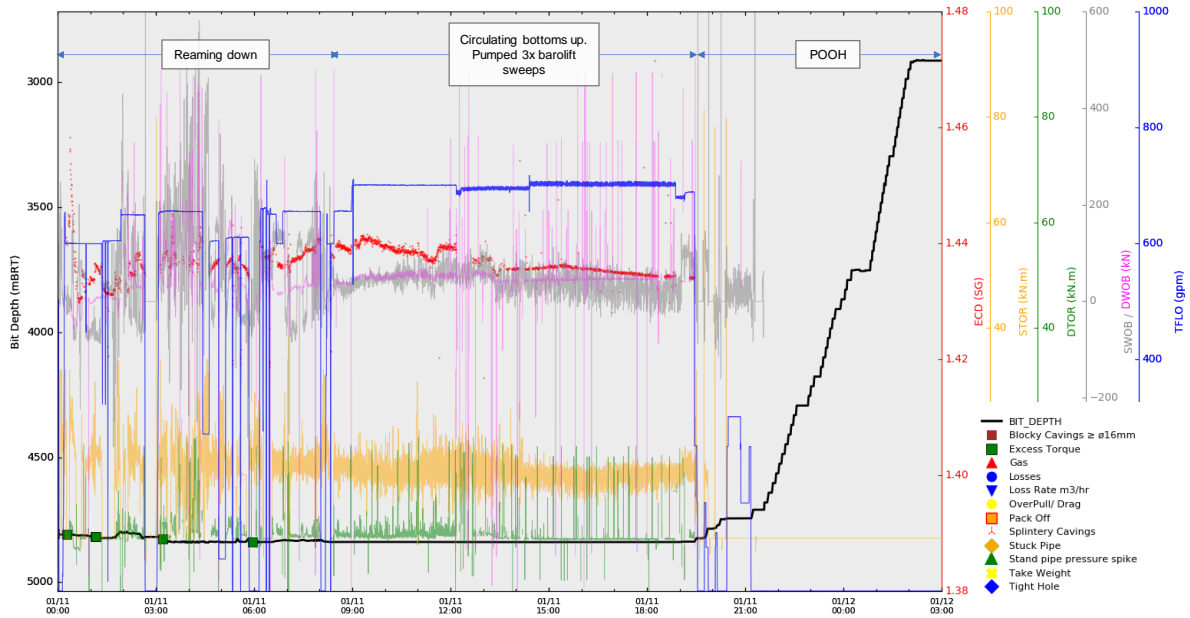
Figure 1 Drilling experiences over the last 24 hrs

Whilst some minor high torque and WOB was encountered at ~ 4806 and 4821 mBRT when reaming down, the wellbore was reamed with no major indications of increasing instability. The BHA assembly was unable to pass 4,841 mBRT which is a few metres above where good hole conditions are believed to exist. See memory resistivity data from previous BHA run (Figure 5)

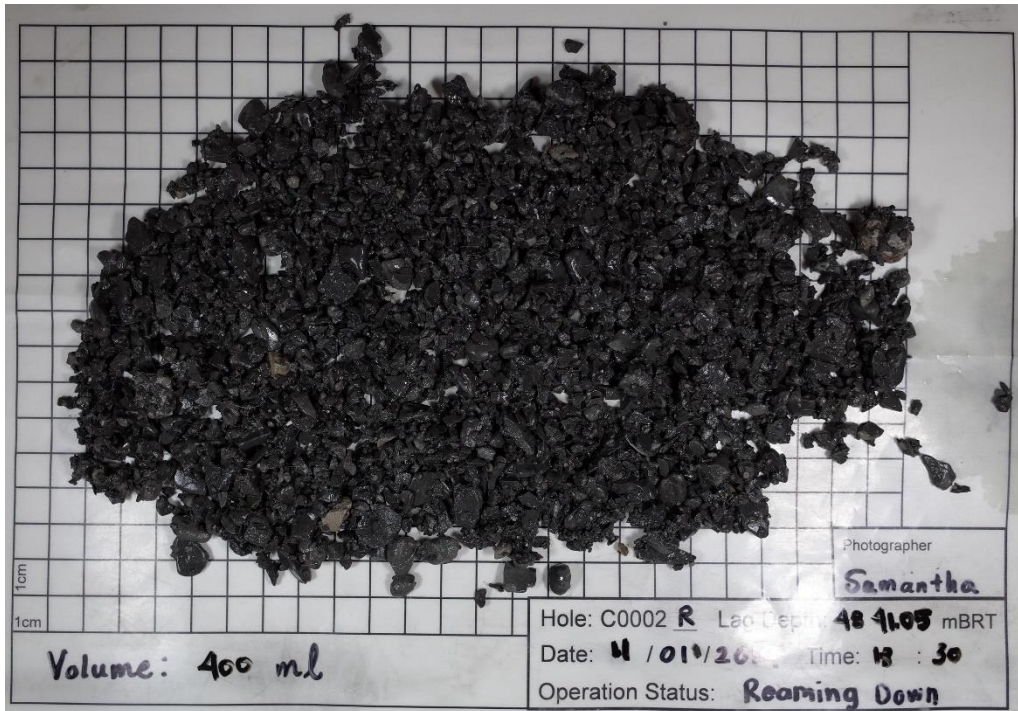
Figure 4 Example of cuttings/cavings > \varnothing 4mm (taken from 400cc RTG Samples)

- The predominant cuttings during reaming down and circulation are fresh small blocky cuttings $\leq \varnothing$ 10 mm.
- Large amounts of tuff (<50%) was present during reaming down and effectively absent (<1%) during circulation at 4841.05 mBRT bit depth.
- Whilst the volume of cuttings increased with increasing circulation and BaroLift sweeps, the size and proportion reduced after several hours of circulation or ~ 5x bottoms up w/ 3x barolift sweeps.

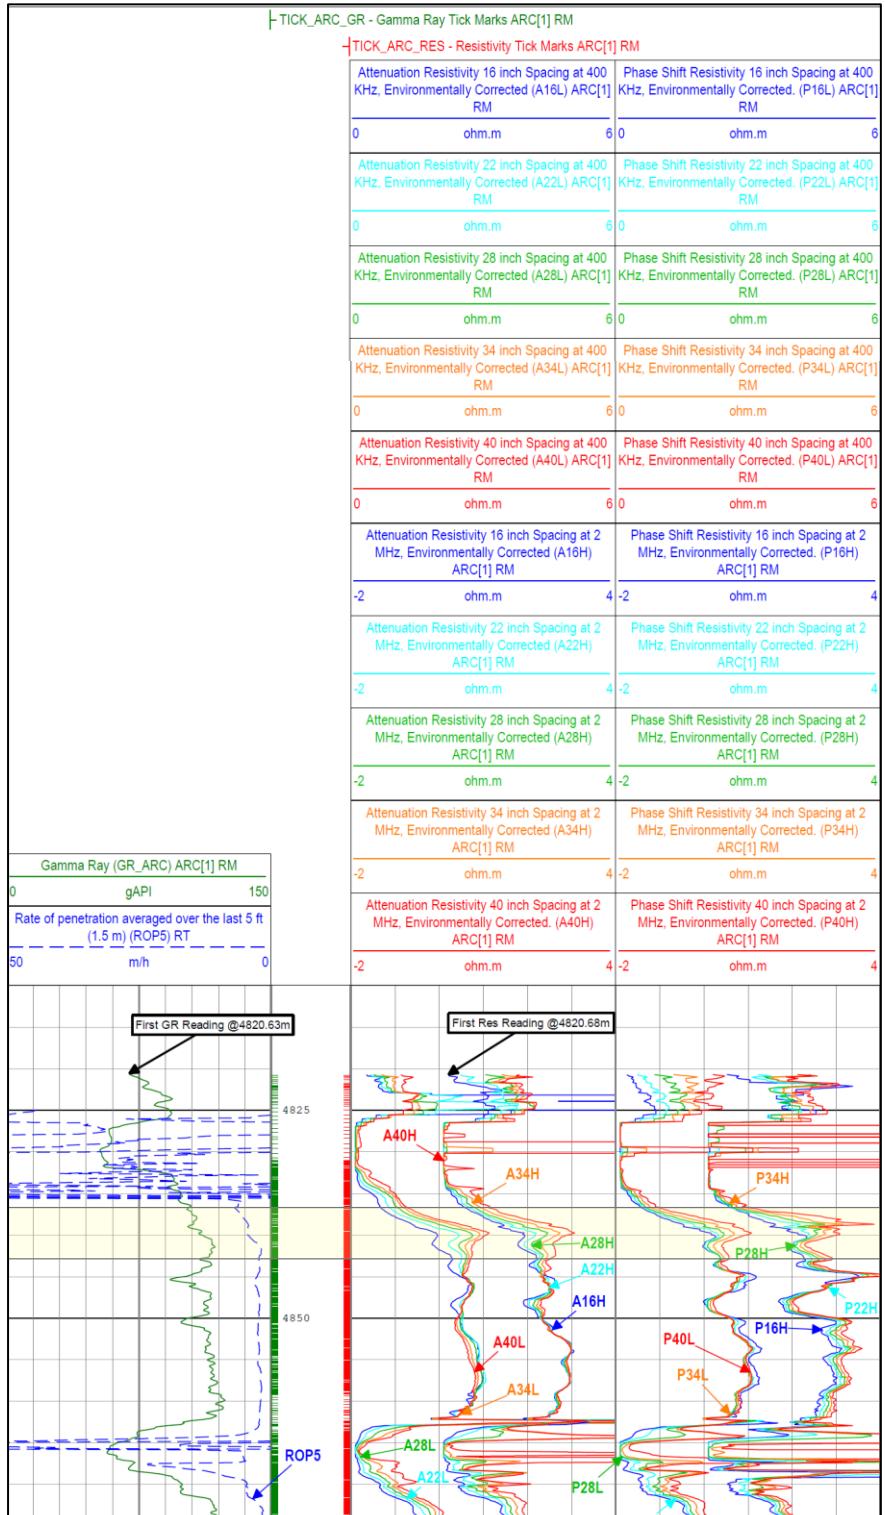
Figure 5 Recorded Mode LWD Log from BHA #20

Yellow box in Figure 5 shows depth at 4,840mBRT where hole condition appears to improve.
