# IODP EXP 358 Daily Geomechanics Report

## Report #073 20190121

Site Name:	C0002	Hole Name:	R
Water Depth:	1,939.0 m	RT-MSL:	28.5 m
0600h Hole Depth:	5,052.0 mBRT (5049.0) (mTVD)	Section TD:	5,667.5 mBRT (5,664.5) (mTVD)
Section #:	1	CSG Depth/Size:	4,818.0 mBRT 11-3/4" ESET inches
Static MW:	1.39 sg	Current ECD:	- sg
FIT/LOT/ XLOT:	N/A Note: 1.46sg FIT @ 4,757mBRT		
Current formation/ lithology:	Shale		
Sensor Offsets from the Bit:	N/A		
Other BHA Offsets from the Bit:	N/A		
Current Operations:	Continued attempting to free the drill out cement BHA.

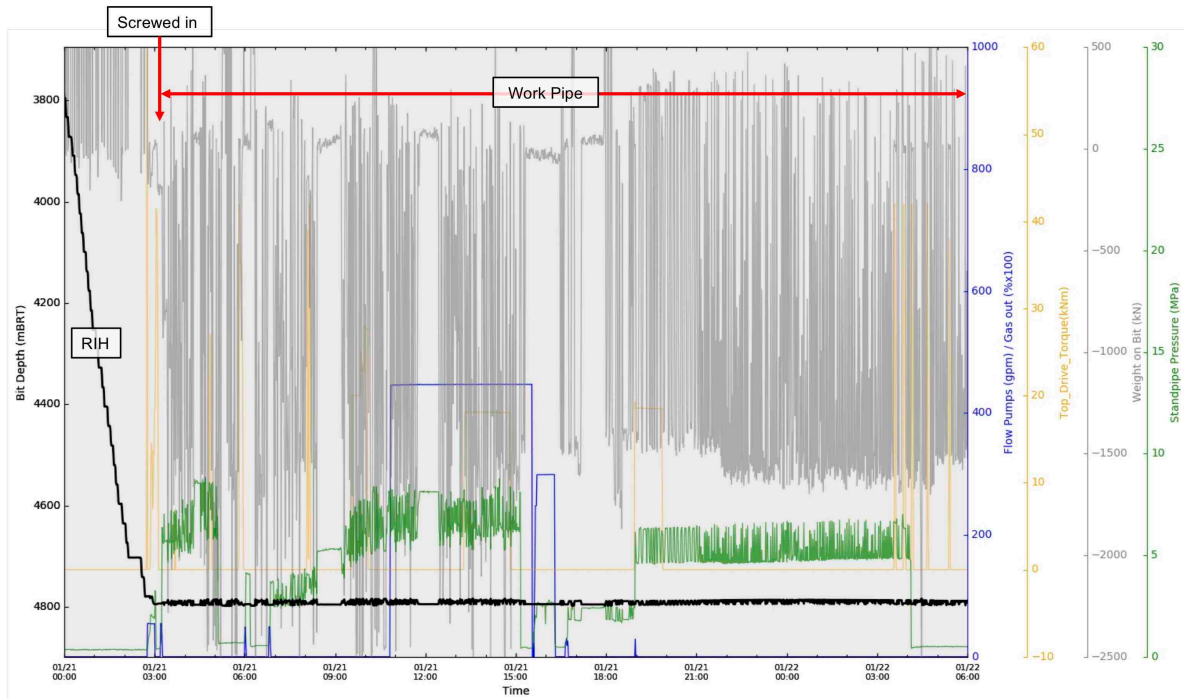
**Figure 1 Drilling Experiences over last 27hrs**

No particular indication related to borehole condition was observed.
