# IODP EXP 358 Daily Geomechanics Report

Report #084 20190201

Site Name:	C0002	Hole Name:	S
Water Depth:	1,939.0 m	RT-MSL:	28.5 m
0600h Hole Depth:	4,779.0 mBRT (4,777.0) (mTVD)	Section TD:	6,000.0 mBRT (5,998.0) (mTVD)
Section #:	1	CSG Depth/Size:	4,818.0 mBRT 11-3/4" ESET inches
Static MW:	1.39 sg	Current ECD:	- sg
FIT/LOT/ XLOT:	N/A Note: 1.46sg FIT @ 4,757mBRT		
Current formation/ lithology:	Shale		
Sensor Offsets from the Bit:	N/A		
Other BHA Offsets from the Bit:	N/A		
Current Operations:	Continued RIH Whipstock and Milling BHA. Settled Whipstock at 4778.5 mBRT successfully. Cut window from 4769.5 mBRT to 4773 mBRT then drilled down rat hole to 4779 mBRT. Performed circulation for hole cleaning.

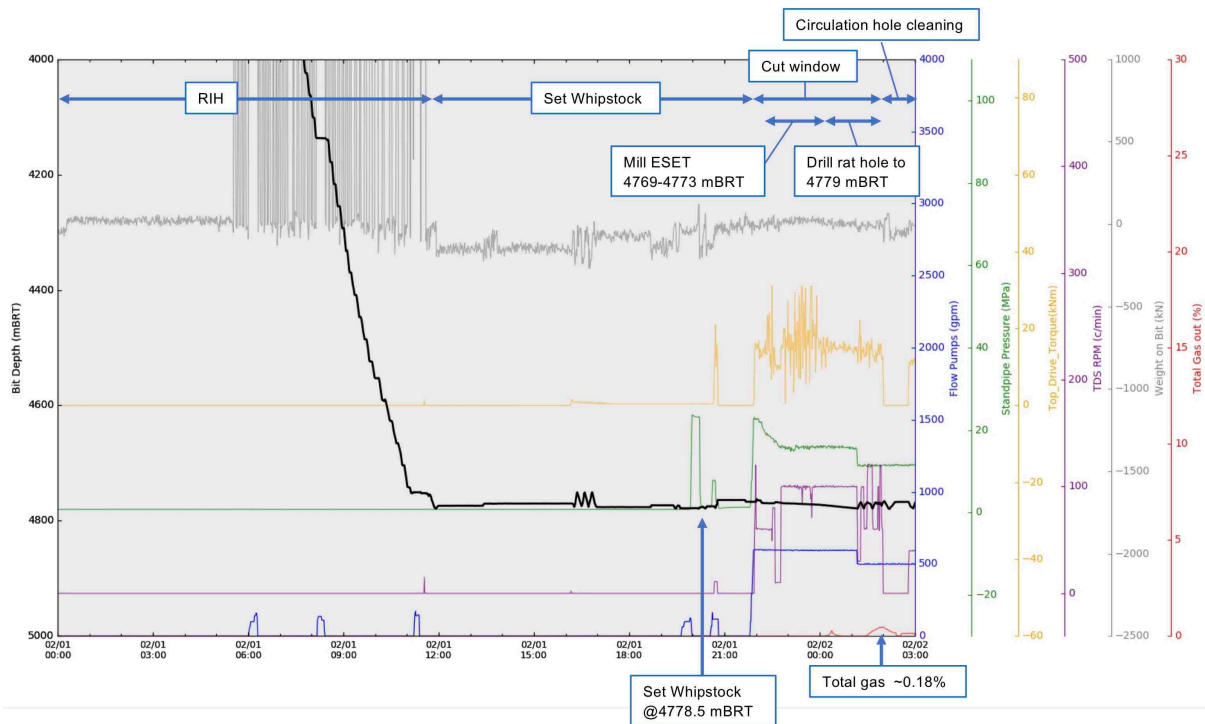
**Figure 1 Drilling Experiences over last 27hrs**

No particular indication of change in borehole condition was observed. Gases ~0.18% were detected at surface 3 hours later after commencing window cut.
