IODP EXP 358 Daily Geomechanics Report

Report #092 20190209

Site Name:	C0002	Hole Name:	S
Water Depth:	1,939.0 m	RT-MSL:	28.5 m
0600h Hole Depth:	4,901.4 mBRT (4,899.4) (mTVD)	Section TD:	6,000.0 mBRT (5,998.0) (mTVD)
Section #:	1	CSG Depth/Size:	4,769~4,775 mBRT 11-3/4" ESET inches
Static MW:	1.35 sg	Current ECD:	1.39 sg
FIT/LOT/ XLOT:	N/A Note: 1.46sg FIT @ 4,757mBRT		
Current formation/ lithology:	Shale		
Sensor Offsets from the Bit:	N/A		
Left BHA to be fished:	8-1/2" PDC Bit (AxeBlade XZ716): 0~0.258 m Xceed675 8-3/8" Stabilizers: 0.258~8.027 m Lower C-Link 675: 8.027~10.971 m		
Current Operations:	Continued POOH. Inspection of the BHA on surface indicated that the BHA components below Lower C-Link (Bit, Xceed and C-Link lower Sub) were missing, requiring the need to fish for the components left in the hole. Made up 8-1/8" Overshot BHA and RIH. Successfully reentered the C2S and the experienced minor tight hole conditions between 4801-4805 mBRT. Bit depth 4838 mBRT as of 06:00 Feb.10.

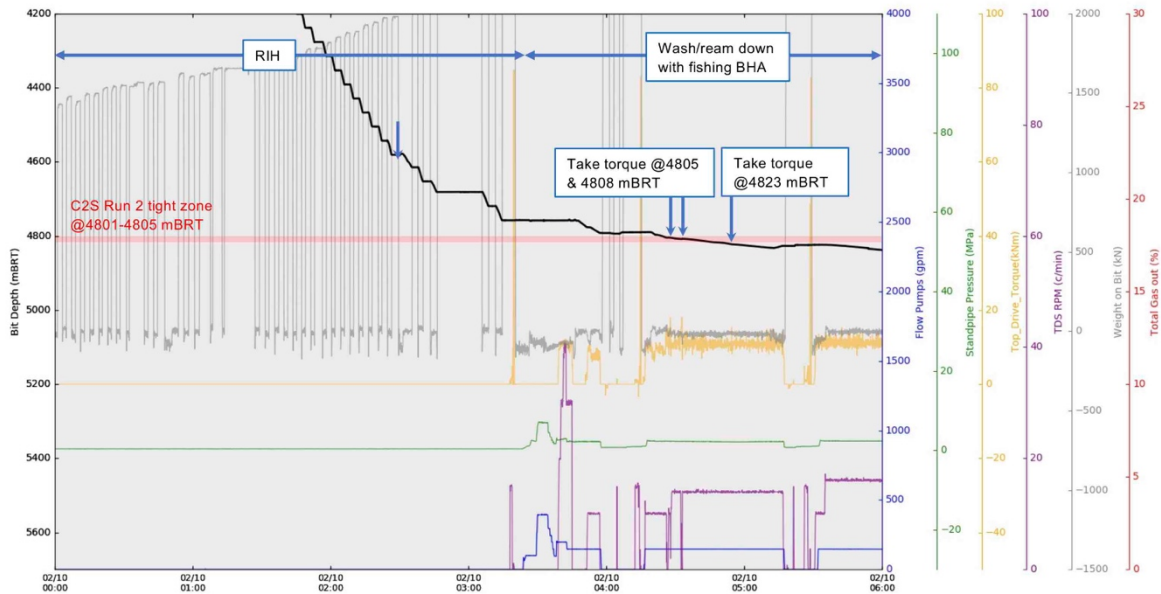
The fishing BHA successfully reentered C2S, and between 4801-4805 mBRT while RIH, small obstacles were encountered resulting in minor tight hole conditions. RIH continued with no adverse conditions.

Figure 1 Drilling Experiences over last 6 hrs

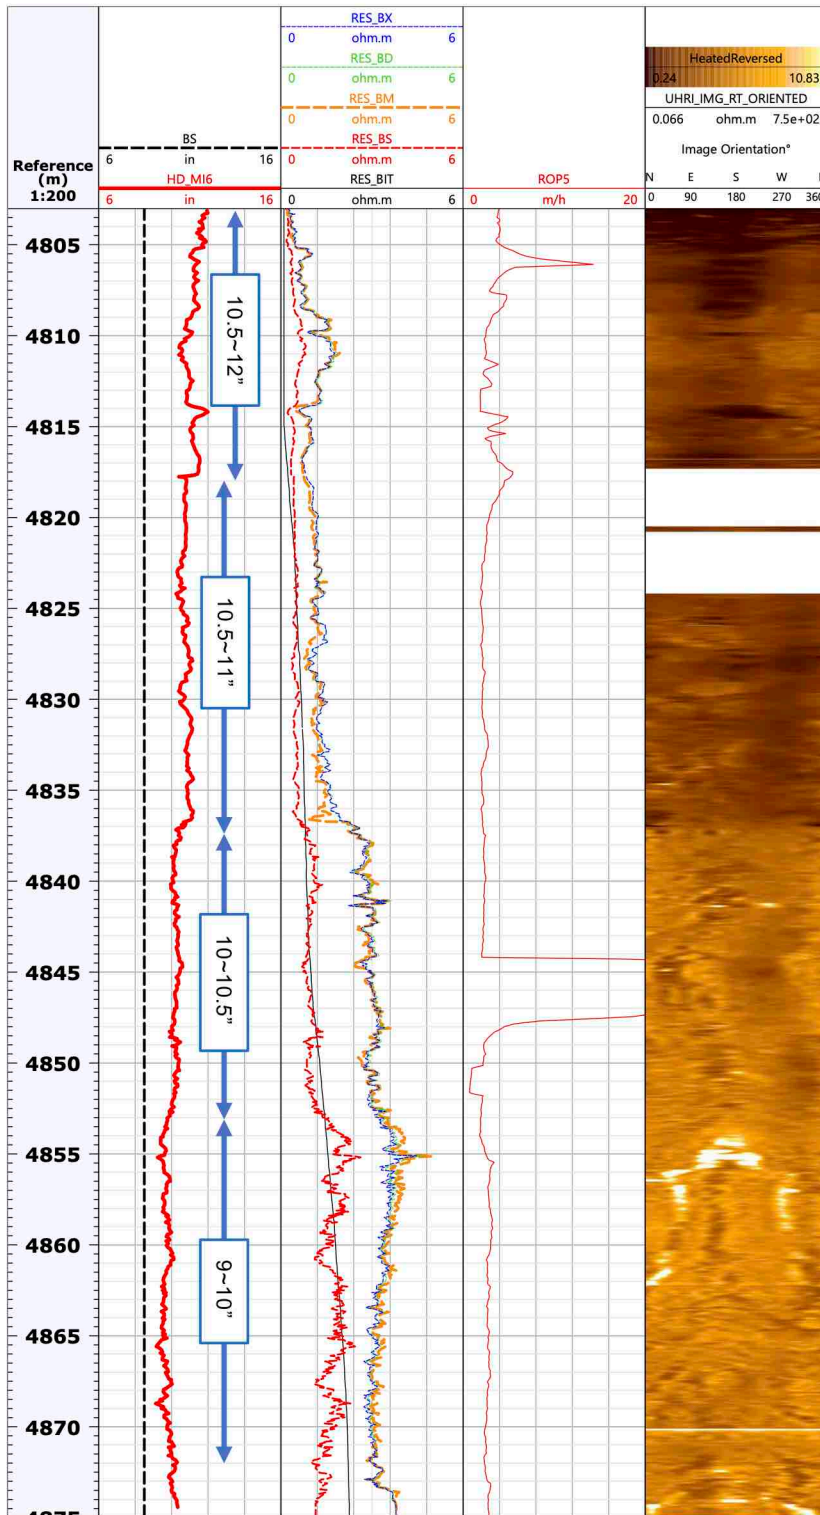
A general indication of hole conditions is summarized in Figure 2 showing a calculated eCaliper data along with image data in geographic reference frame. The average resistivity curves (especially, the shallow resistivity) and the resistivity images, indicate that the most enlarged hole sections are between the window and ~4837 mBRT. Below 4837 mBRT, it appears hole conditions improve inferred from a slight decrease in apparent hole enlargement and improved definition of features in the borehole image data.

Figure 2 eCaliper profile based on LWD resistivity (predominately Shallow depth of investigation) collected in C2S Run 1. Although the average hole diameter is larger than the bit diameter, there does appear to be a trend towards minor improvement in hole condition below 4855 mBRT.

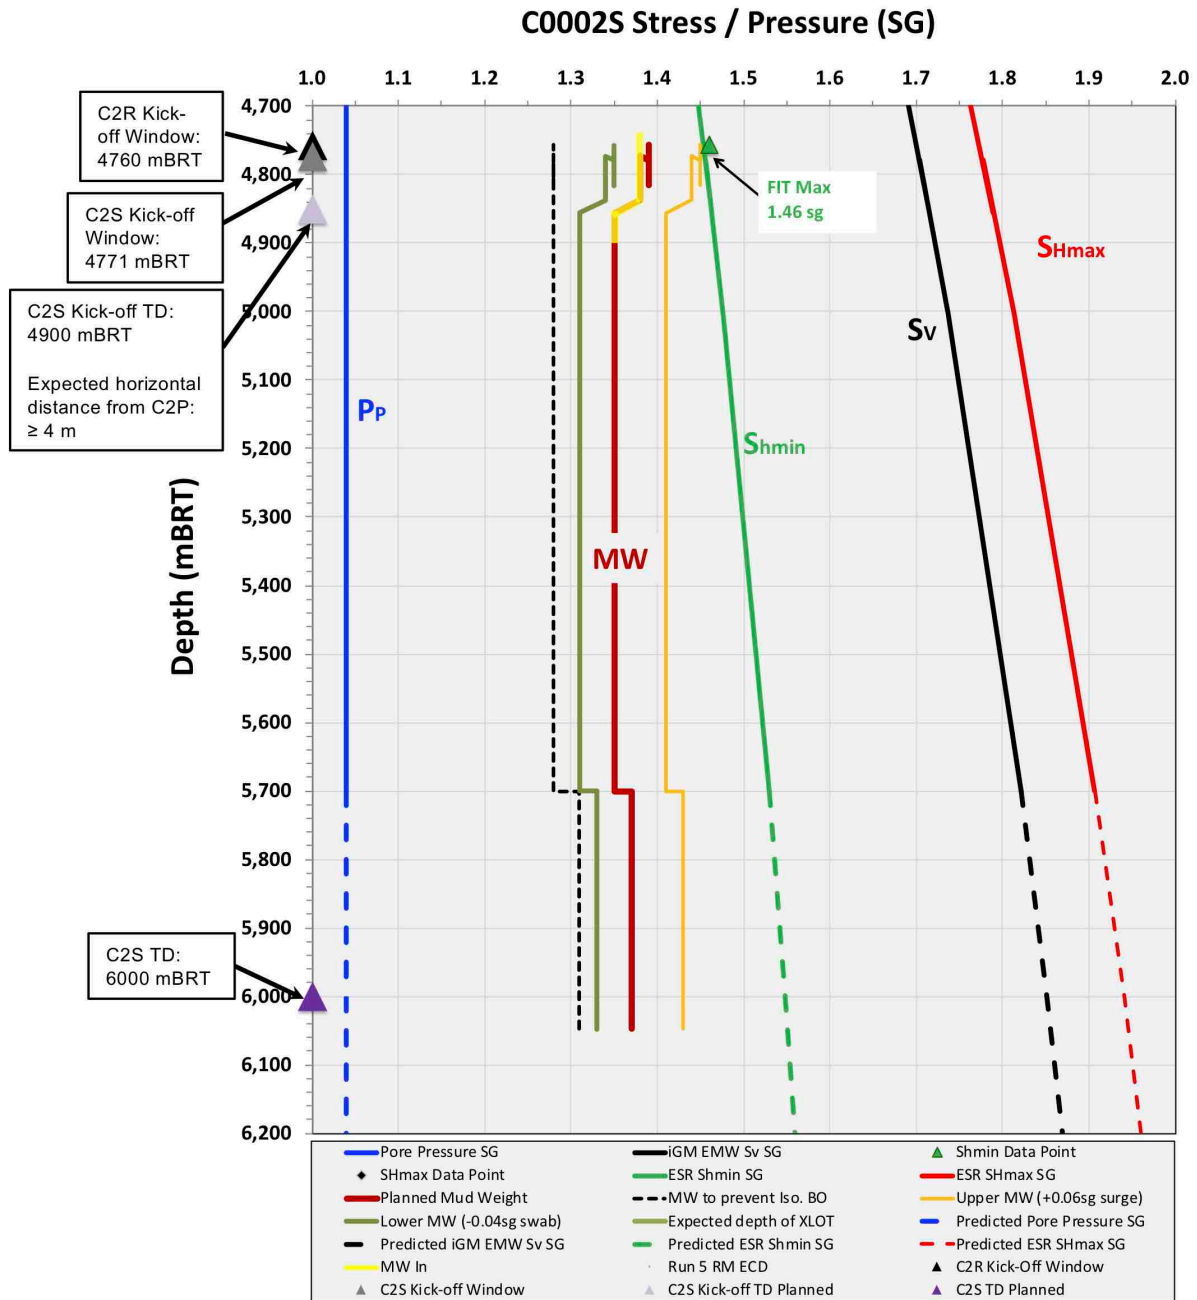
No change in the current stress model.

Figure 3 Current stress model for C2S
