IODP EXP 358 Daily Geomechanics Report

Report #094 20190211

Site Name:	C0002	Hole Name:	S
Water Depth:	1,939.0 m	RT-MSL:	28.5 m
0600h Hole Depth:	4,901.4 mBRT (4,899.4 mTVD)	Section TD:	6,000.0 mBRT (5,998.0 mTVD)
Section #:	1	CSG Depth/Size:	4,769~4,775 mBRT 11-3/4" ESET inches
Static MW:	1.35 sg	Current ECD:	- sg
FIT/LOT/ XLOT:	N/A Note: 1.46sg FIT @ 4,757mBRT		
Current formation/ lithology:	Shale		
Sensor Offsets from the Bit:	N/A		
Current Operations:	Recovered Overshot fishing BHA on surface but no evidence of tagging the fish on Overshot. Decision made to sidetrack off cement plug. RIH with Diverter Assembly to 4,806 mBRT. Encountered a tight zone between 4807-4810 mBRT and no success in passing. Decided to POOH to change the cementing assembly.

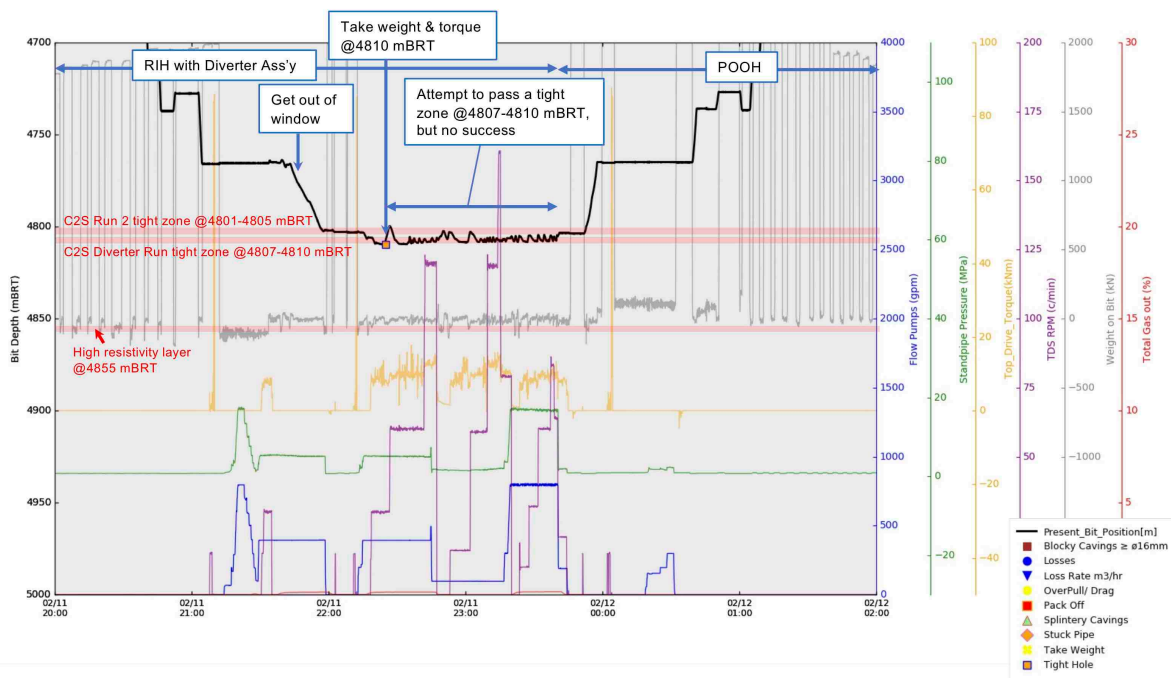
- No adverse condition was observed down to 4806 mBRT while RIH with Diverter Assembly.
- Took weight and torque at 4810 mBRT.
- Encountered a tight zone between 4807-4810 mBRT, about 6 m deeper than that experienced during LWD Run 2.
- No success in clearing.

Figure 1 Drilling Experiences from 20:00 Feb.11 to 02:00 Feb.12.

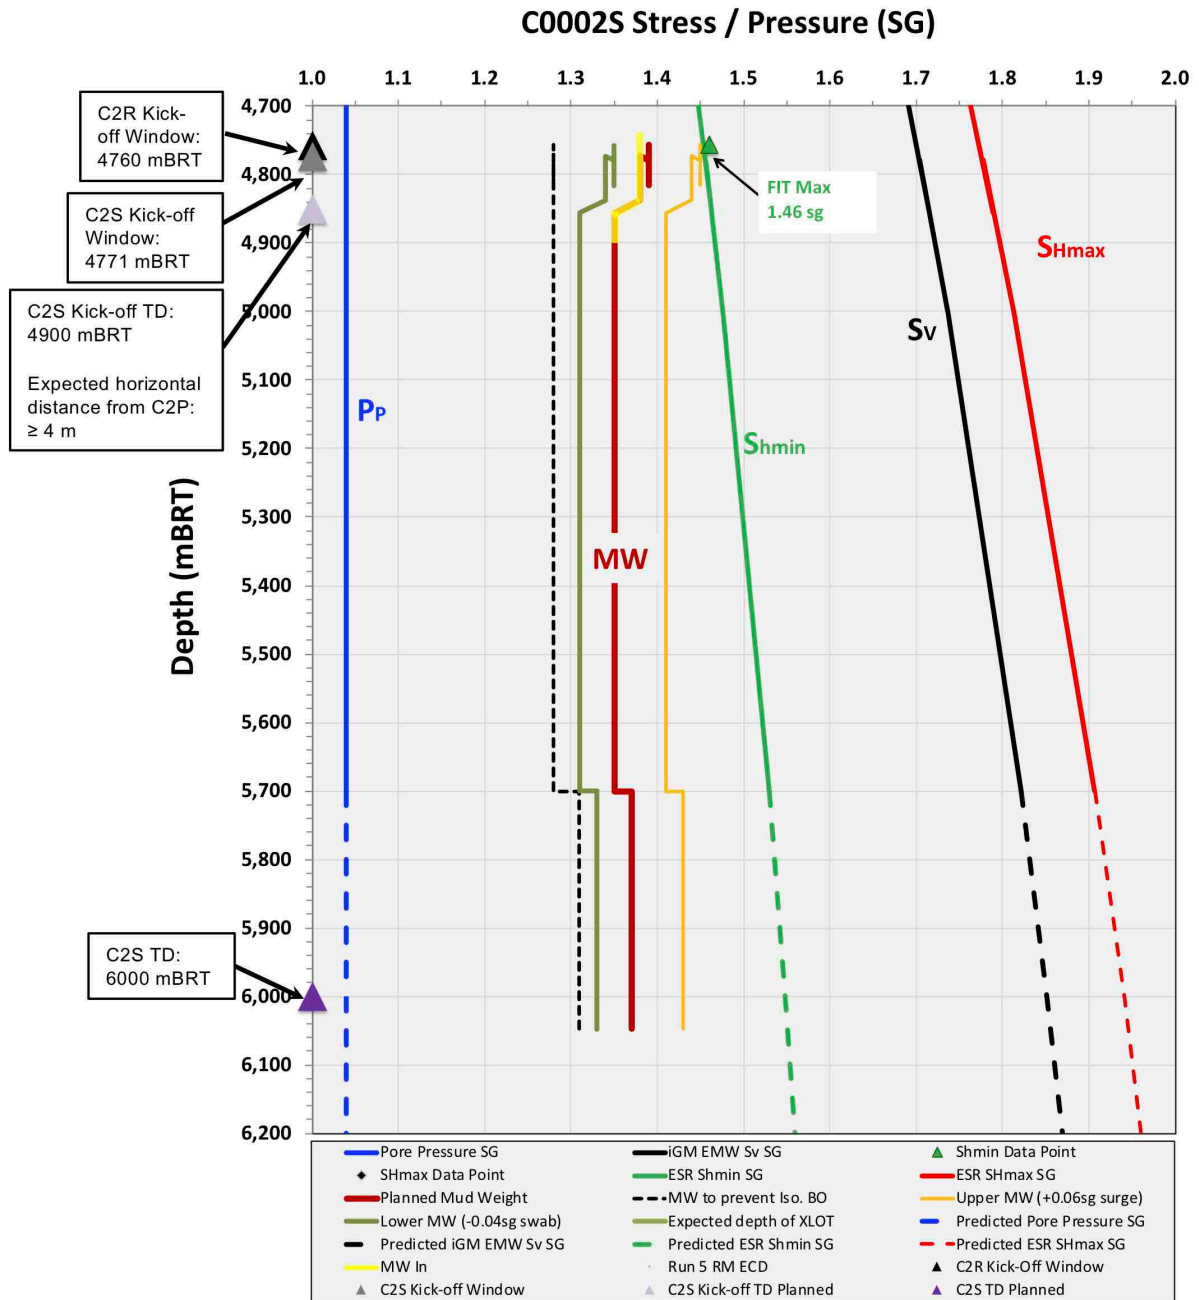
No change in the current stress model.

Figure 2 Current stress model for C2S
