IODP EXP 358 Daily Geomechanics Report

Report #054 20190102

Well Status

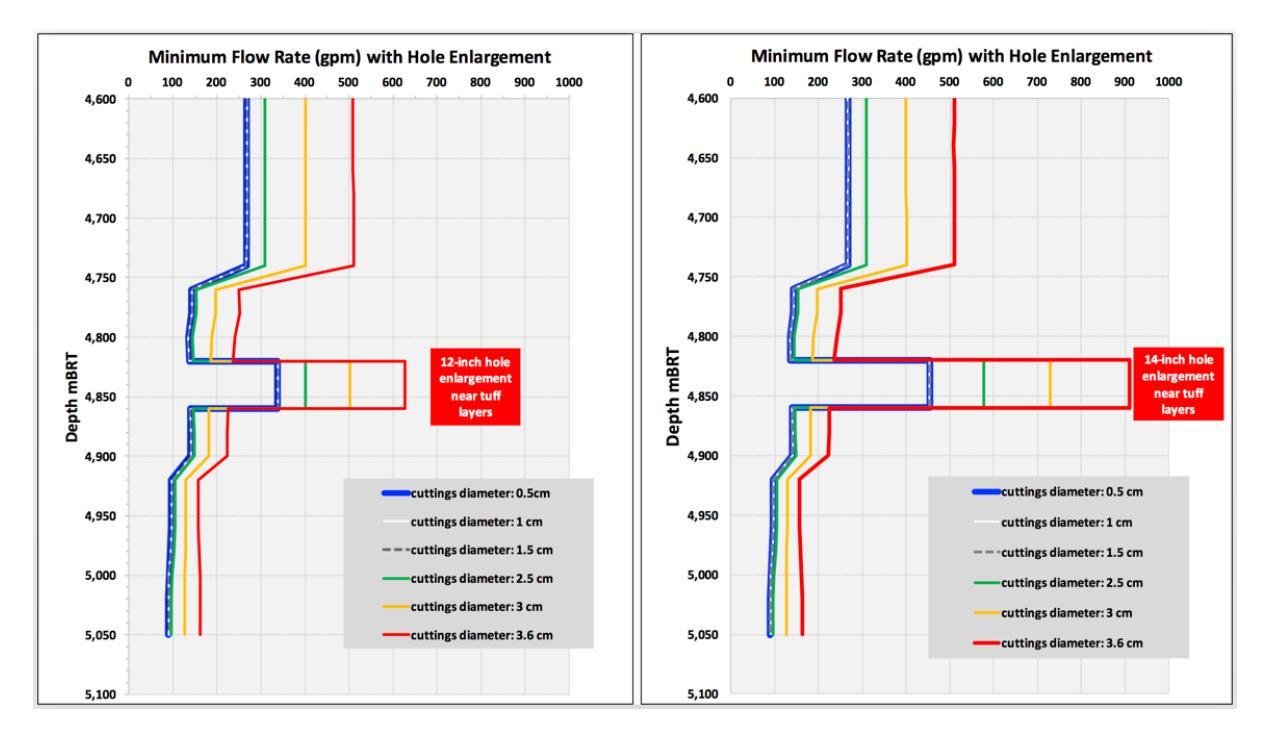
Calculated flow rate requirements to remove rock fragments of various sizes are shown in Figure 1. The hole enlargement centered at ~4,840 mBRT would be for a 12-inch hole enlargement (left plot)

and a 14-inch hole enlargement (right plot). If rock fragments are less than a centimetre in diameter, 480 gpm should sufficient to clean the hole. It would be difficult to remove blocky fragments that are \sim 3 cm long using 480 gpm; however, the extra Barolift may help compensate.

Figure 1: Flow-rate modelling for cleaning the C2R Kick-Off section for various rock fragment sizes assuming a 1.39 SG MW and a 8.5-inch hole. Modelling the impact that a hole enlargement centered at ~4,840 mBRT has on hole cleaning indicates an increase in flow rate is needed to remove large cavings for a 12-inch hole enlargement (left) and 14-inch hole enlargement (right).

The 3rd and final application of Barolift would occur after the bit was RIH to a few meters from kick off TD. If no fill is encountered, applying the 3rd Barolift application would serve to add assurance that the hole is clean. If large blocky rock fragments fell off the ledge(s) near 4,840 mBRT, this 3rd Barolift application would be the last opportunity to attempt to clean the hole.

If large blocky rock fragments remain at the bottom of the C2R Kick-Off section that were not removed using a ~480 gpm flow rate, the next LWD drilling assembly would need to clean the hole. Removing any potential fill prior to drilling Section #1 is more likely since the next LWD Telescope tool can support a higher flow rate (e.g., 600-900 gpm).
