# IODPEXP 358 Daily Geomechanics Report

Report #004 20181113 Final 4867

Site Name:	C0002	Hole Name:	Q
Water Depth:	1,939.0 m	RT-MSL:	28.5 m
Current Depth:	4,867.2 mBRT (4,865.3) mTVD	Section TD:	4,867.2 mBRT (4,864.0) mTVD
Section #:	0	CSG Depth / Size:	- mBRT
Static MW:	1.37 sg	Current ECD:	- sg
Current formation/ lithology:	Shale		
Sensor Offsets:	-		
Current Operations:	Continued POOH Milling BHA and on surface at 09:40. Confirmed that mills became undergauge. RIH another Milling BHA for dressing the window from 14:25. No success to pass through the 11-3/4" CSG hanger, then POOH BHA to change out from 04:30 Nov. 14. 3004.0 mBRT as of 06:00.

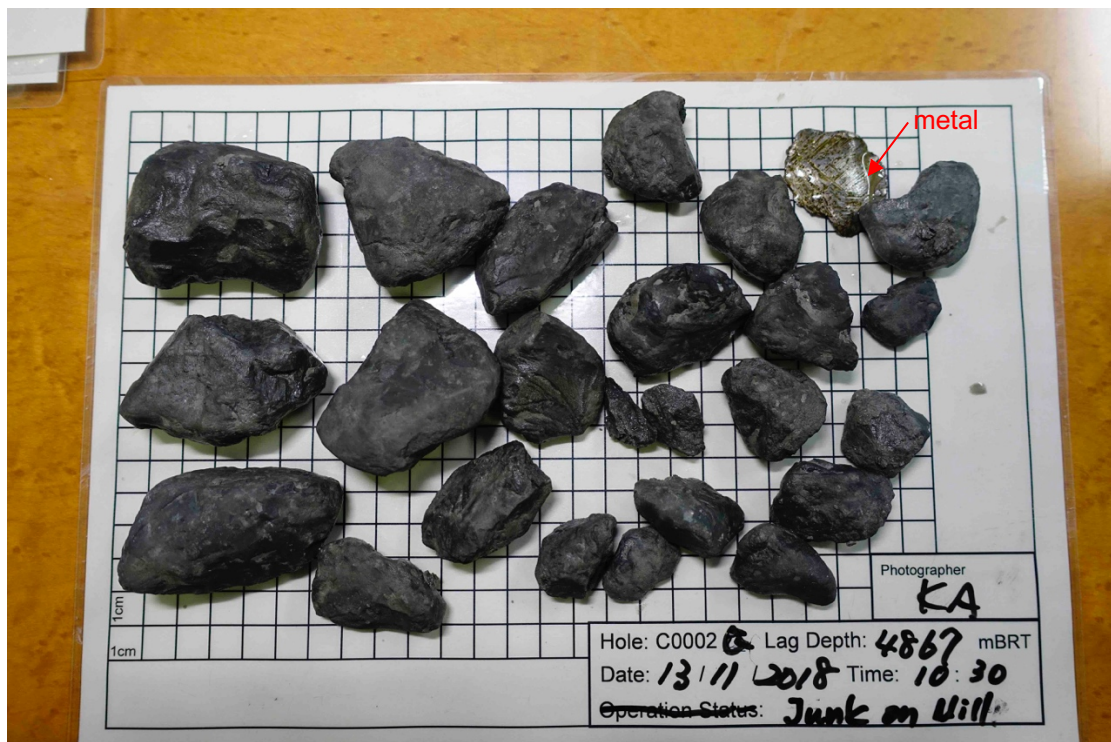
Middle to coarse pebble-sized blocky cavings were recovered from the kick-off window with clayey cuttings adhered in between blades of the middle mill on the Milling BHA. No cavings with so large sizes had been seen at the shakers during the milling operations. They consist of mudstone, subangular to subrounded in shape, moderately hard but fragile in general. They may be derived from the original hole because of their rounded shapes. However, in case that they had spalled from the rat hole wall and even if they had originally sharp edges, they may have a chance to be worn out after trapped in the mill. Therefore, it is difficult to judge where they came from. In either case, we need to consider that a certain amount of larger cavings are still possibly accumulated in the rat hole.

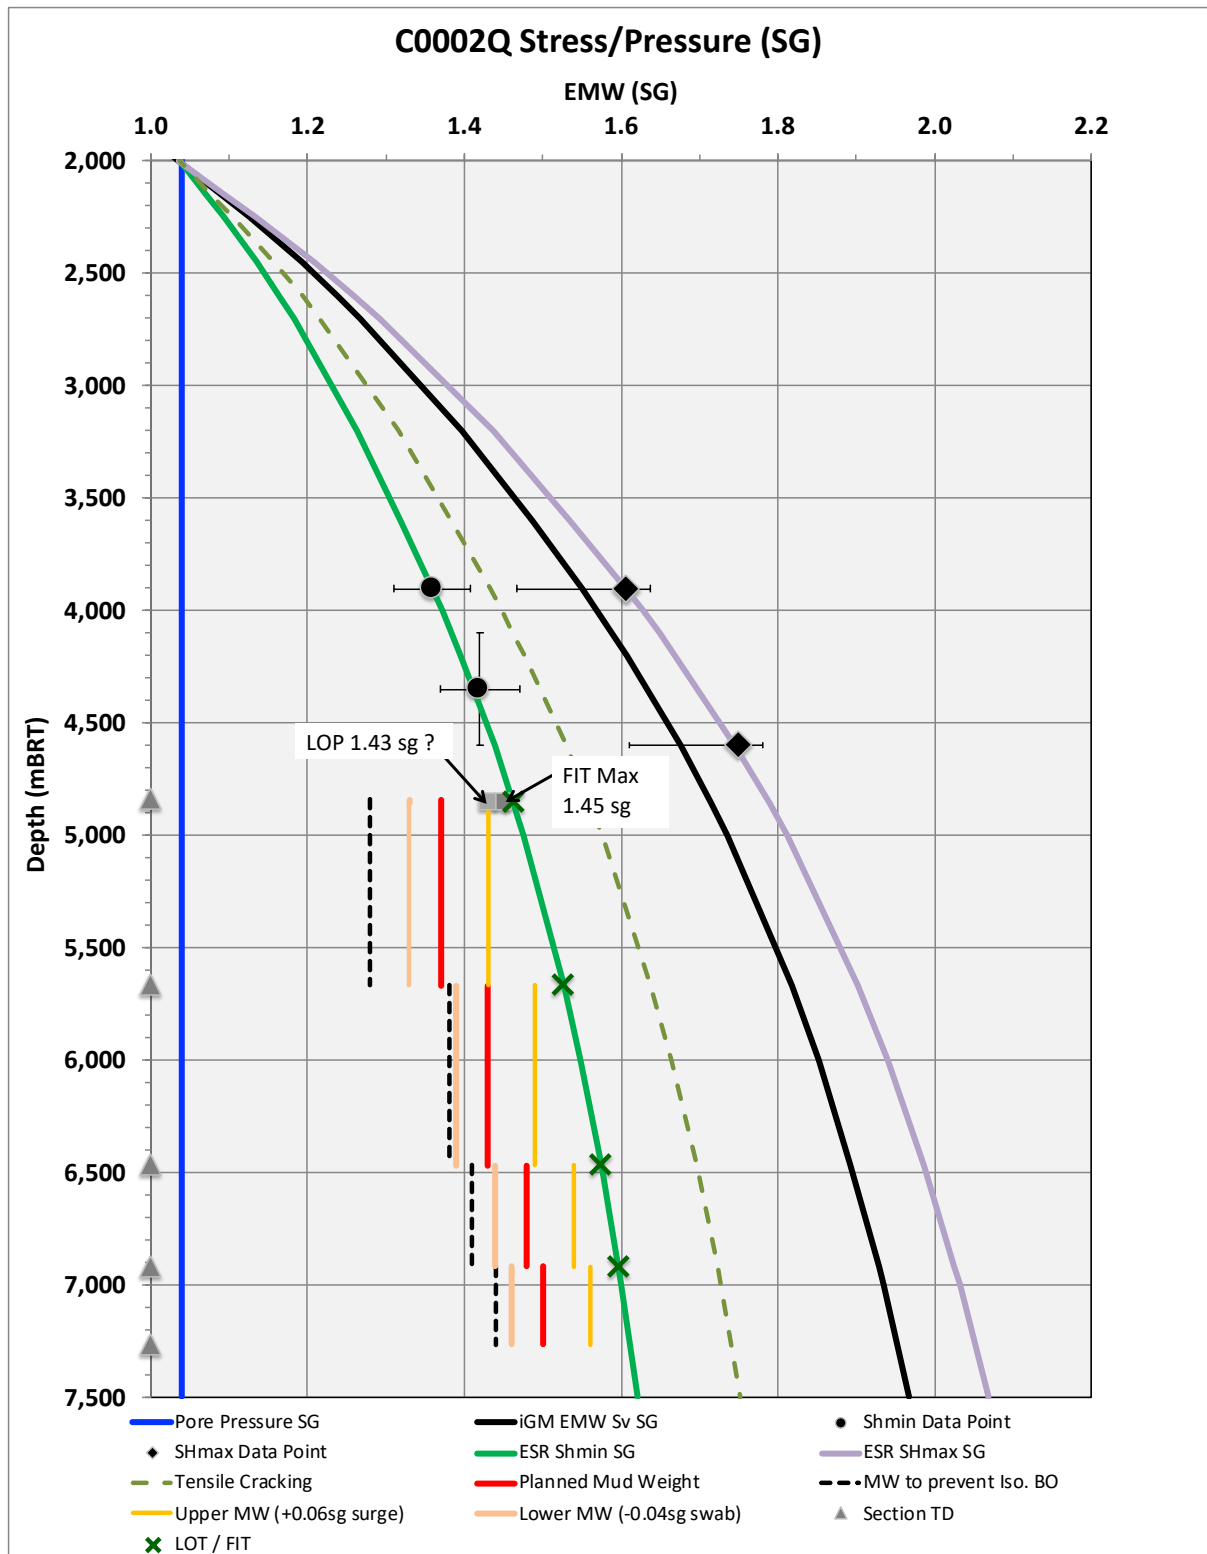
The planned mud weight of 1.37 sg with an operational safety upper margin of +0.06 sg (surge pressure), required a formation pressure integrity up to 1.43 sg. The FIT in the C0002Q rat-hole achieved that objective. It is possible that a leak-off pressure of 1.43 sg may have occurred, but a maximum pressure of 1.45 sg was achieved before the pumps were shut-in. If a leak-off pressure of 1.43 sg did occur, this implies a leak-off-test (LOT) had occurred (no longer a FIT). A leak-off-pressure of 1.43 sg may be interpreted as a possible approximation of  $S_3$  or  $S_{hmin}$  stress magnitudes.

This interpretation would require a pass of the LWD image log across the rat-hole section to identify whether a new tensile was created, or drilling fluids leaked into a pre-existing bedding plane or natural

fracture. The former would have direct implications of S3, while the latter would require further information such as bedding plane orientation.

Therefore, for now we will continue to call this test a FIT until we learn more from the LWD image data after it passes through the rat-hole.

Potentially no changes to the pre-drill geomechanical model because FIT (Formation Integrity Test) does not directly contribute sufficient information for constraining or refining subsurface earth stresses. By design, FIT is intended to determine whether the planned mud weight can be supported by the formation.
