<https://doi.org/10.14379/iodp.proc.380.103.2018>

Site C0006¹

Keywords: International Ocean Discovery Program, IODP, *Chikyu*, Expedition 380, Site C0006, accretionary prism, frontal thrust, prism toe, Shikoku Basin, Nankai Trough, borehole observatory, long-term borehole observatory, LTBMS, Nankai Trough Seismogenic Zone Experiment, NanTroSEIZE, Dense Oceanfloor Network System for Earthquakes and Tsunamis, DONET, tsunami, tsunamigenic fault

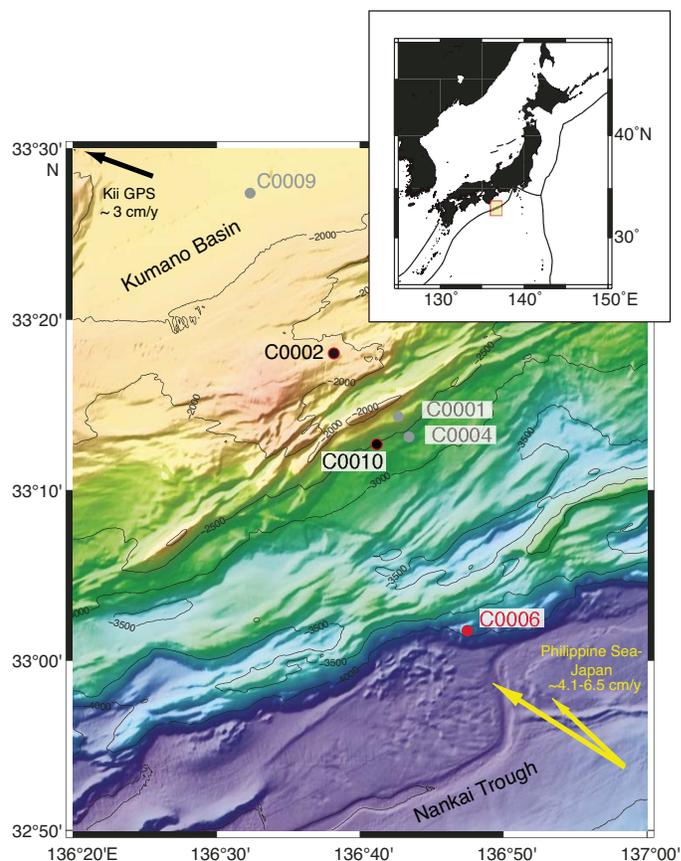
Figure F1. Site C0006 location. LTBMS Sites C0002 and C0010 are also shown. Inset shows region in relation to Japan. Black arrow = motion of Kii Peninsula determined from GPS measurements (Heki, 2007). Yellow arrows = computed far-field convergence vectors between the Philippine Sea plate and Japan (Seno et al., 1993; Miyazaki and Heki, 2001).

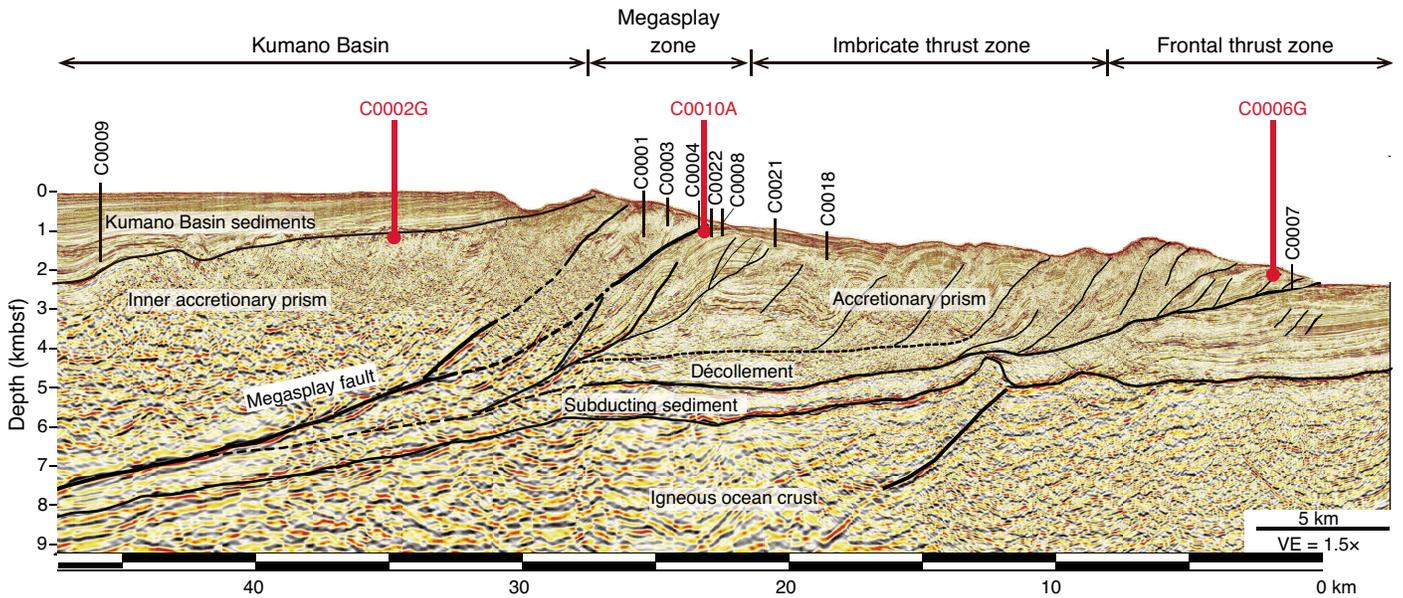
Figure F2. Interpreted seismic cross section of Kumano transect offshore and southeast of Kii Peninsula (modified from Moore et al., 2009; after Strasser et al., 2014), with LTBS Sites C0002, C0010, and C0006. NanTroSEIZE Sites C0013 and C0014 on the incoming Philippine Sea plate are not shown. VE = vertical exaggeration.

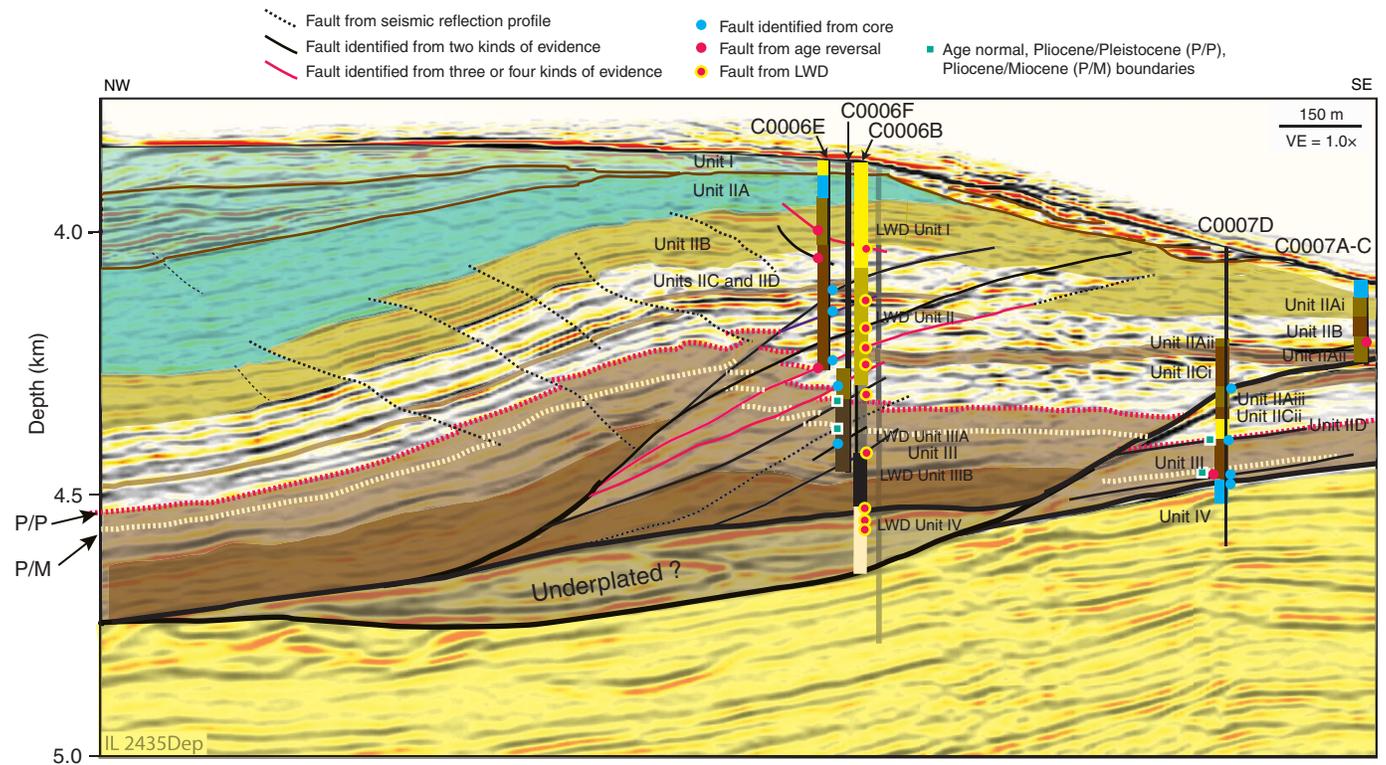
Figure F3. Interpreted seismic reflection depth section (Profile IL 2435Dep) around Sites C0006 and C0007 based on integrated interpretation of core and log data from the boreholes. Vertical gray line in the background indicates approved drilling location and penetration (1800 mbsf) approved by the IODP Environmental Protection and Safety Panel (EPSP) for Expedition 314 proposed Site NT1-03B (Site C0006).

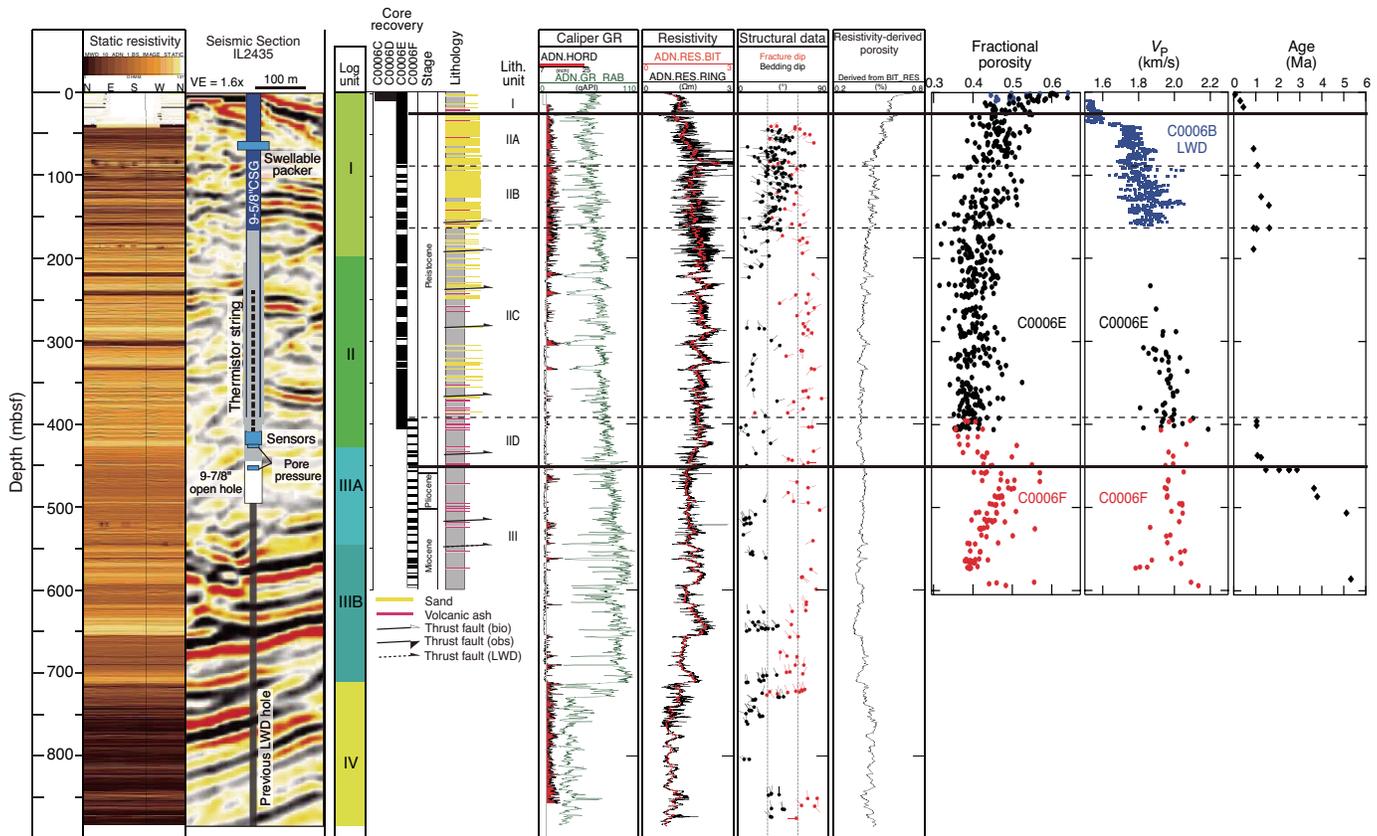
Figure F4. Seismic section and logging and coring results used to determine configuration of the Expedition 380 LTBS installation in Hole C0006G. GR = gamma ray, ADN = azimuthal density neutron tool, RAB = resistivity-at-the-bit tool.

From examination of the Site C0006 cores, Expedition 316 Scientists (2009) identified three primary lithologic units (Figure F4). Unit I extends from the seafloor to ~27 mbsf and comprises Pleistocene trench to slope transition facies. Unit II is composed of Pleistocene trench deposits divided into four subunits based mainly on variations in silt and sand content, with significant repetition of sequences caused by numerous thrust faults. It extends to ~407 mbsf in Hole C0006E and ~450 mbsf in Hole C0006F. Subunit IIA comprises mainly sand-dominated trench wedge deposits, Subunit IIB comprises mixed sand-mud trench wedge deposits, Subunit IIC comprises mud-dominated trench wedge deposits, and Subunit IID comprises deep-marine basin to mud-dominated trench transition

Four primary logging units (Figure F4) were identified based on differing trends and LWD log responses (Expedition 314 Scientists, 2009). Logging Unit I (0–197.8 m LWD depth below seafloor [LSF]) was interpreted to be sandy and muddy deposits. Logging Unit II (197.8–428.3 m LSF) was interpreted to be mud with occasional thick sand layers. Logging Unit III (428.3–711.5 m LSF) was identified as alternating beds of mud and sand and is divided into two subunits. The boundary between Logging Units II and III might be a fault zone (Figure F4). Logging Unit IV (711.5 m LSF to total depth) was interpreted to be underthrust, coarse trench-fill sediments. The main frontal thrust was identified by a sudden decrease in gamma ray values (from ~90 to 20–50 gAPI) across the Logging Unit III/IV boundary.

Based on these results, the target zone for the main LTBS instrument package (strainmeter/seismometer/tiltmeter/pressure sensor) was selected in the deepest part of Logging Unit II at ~410–425 mbsf (Figure F4). The formation in this interval was expected to be relatively competent mudstone suitable for monitoring formation pressure and deformation in the hanging wall at the frontal toe of the prism. With the main package at 410–425 mbsf, the LTBS design also allowed for (1) a deeper pressure monitoring screen in the open hole near the boundary between Logging Units II and III and (2) placement of the thermistor cable from ~400 to 250 mbsf spanning much of Lithologic Subunit IIC.

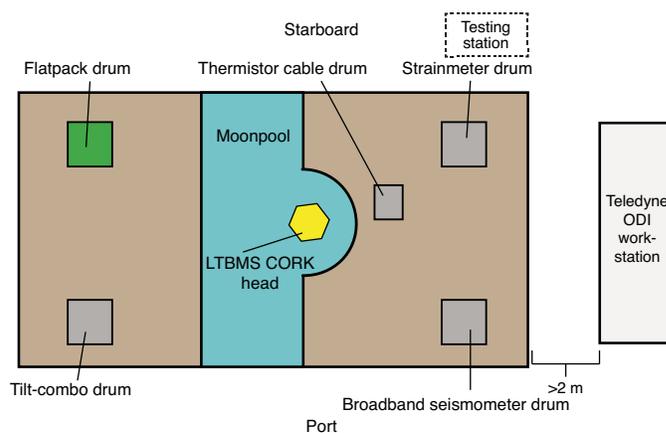
Figure F5. Sensor cable and flatpack drum configuration in the moonpool area, Expedition 380.

While the instrument carrier was progressively lowered into the water by adding 3.5 inch LTBMS tubing joints one by one, the flatpack and sensor cables continued to be attached to the tubing using plastic zip-ties and stainless steel bands. The sensor cables and flatpack were strung up for attachment through cable drums and pulleys set up the moonpool area (Figure F5).

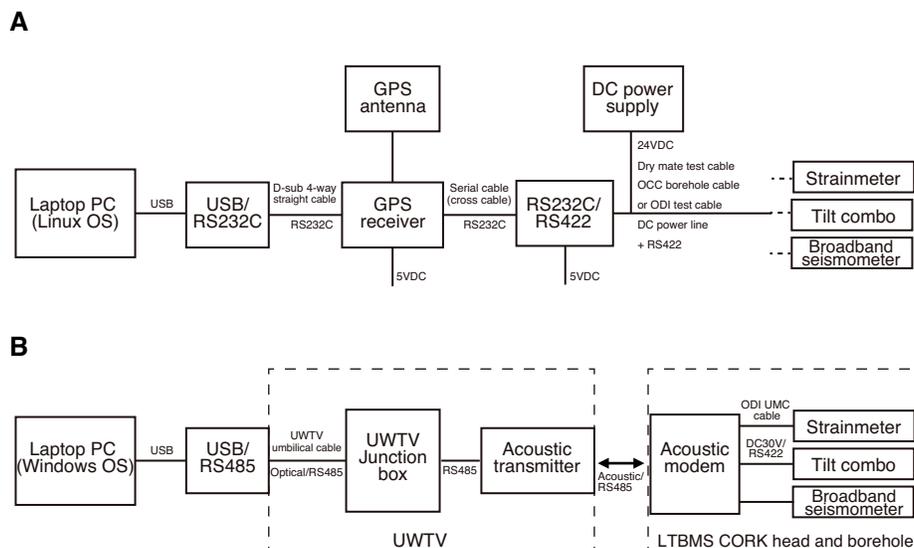
Figure F6. LTBMS sensor health check connection diagram, Expedition 380. A. Before LTBMS deployment. B. After running the LTBMS CORK assembly into the moonpool.

Figure F6 is the connection diagram of the two test rigs. Connection A was used for the direct (wired) connection between the sensor, the sensor cable, and the underwater mateable connectors (UMCs) before LTBMS CORK head deployment. Here, borehole sensors were connected to the borehole cables and/or Teledyne ODI UMCs. RS422/232C and RS232C-USB converters were used to connect the original sensor output (RS422) to a PC port (USB). The converters and GPS receiver were connected by D-sub 9-way straight and cross cables. A DC power supply unit was also used to supply power to the borehole sensors.

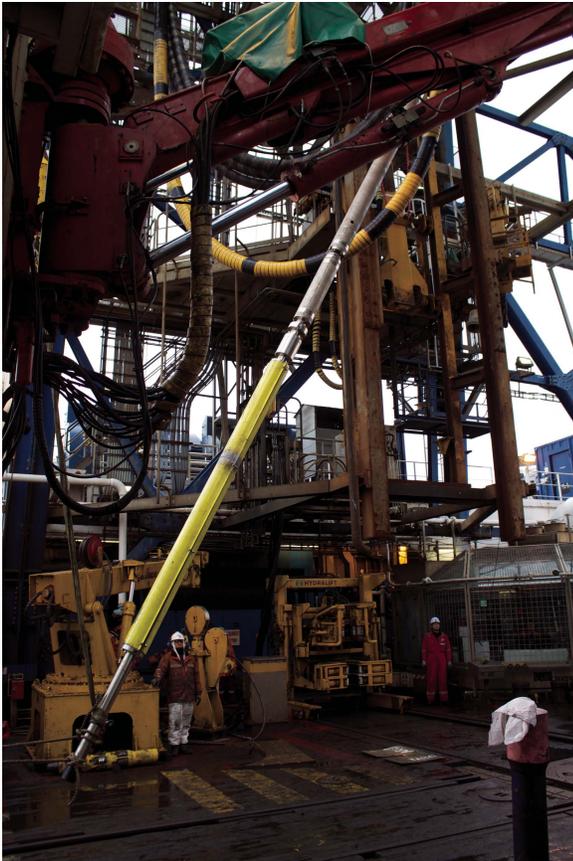
Figure F7. Strainmeter above the drill floor, Expedition 380.

When the test was completed, the strainmeter with a crossover joint attached on the bottom end (for permanent connection to the LTBMS) and top end (used only for lifting the strainmeter for deployment), was loaded onto the riser transport system (RTS) and picked up on the rig floor to attach it to the 3.5 inch LTBMS tubing and ¼ inch hydraulic tubing. (Figure F7).

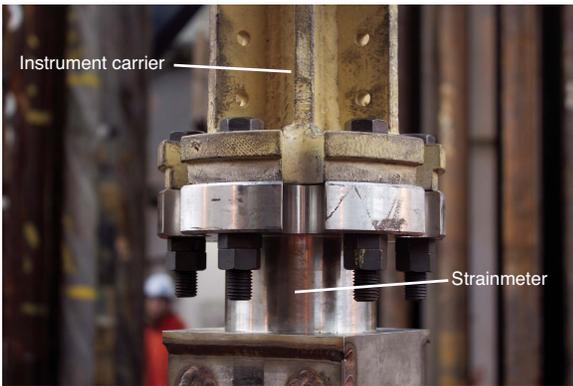
Figure F8. Strainmeter crossover connection, Expedition 380.

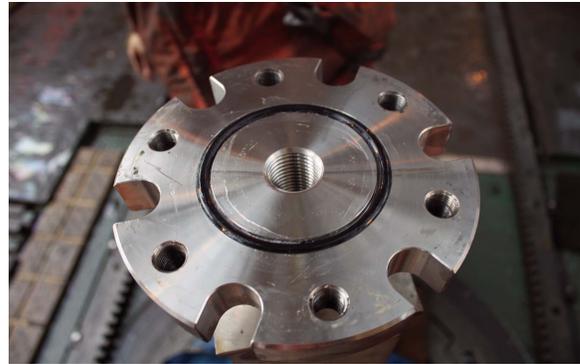
Figure F9. Crossover O-ring, Expedition 380.

With the strainmeter attached to the 3.5 inch LTBMS tubing, the instrument carrier was loaded onto the RTS. The temporary crossover joint, which connected the top of strainmeter to the HPS, was removed to connect the top of the strainmeter to the bottom of the instrument carrier (Figure F8). Before attachment, the condition of the O-ring between the strainmeter and the instrument carrier was checked (Figure F9).

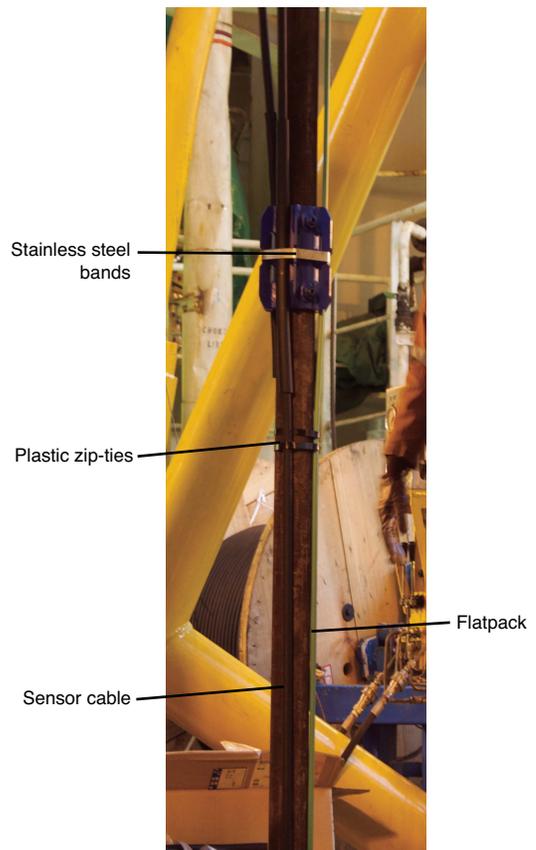
Figure F10. Cables and flatpack connected to the 3.5 inch LTBMS tubing, Expedition 380.

When the instrument carrier, strainmeter, and lower tubing section were lowered into the moonpool, the sensor cables and hydraulic flatpack were connected by Center for Deep Earth Exploration (CDEX) engineers and Mantle Quest Japan (MQJ) crew. The flatpack and sensor cables were attached to the 3.5 inch LTBMS tubing using both plastic zip-ties and SUS stainless steel banding (Figure F10). Metal centralizers were spaced at 2.3 m (for open hole) and

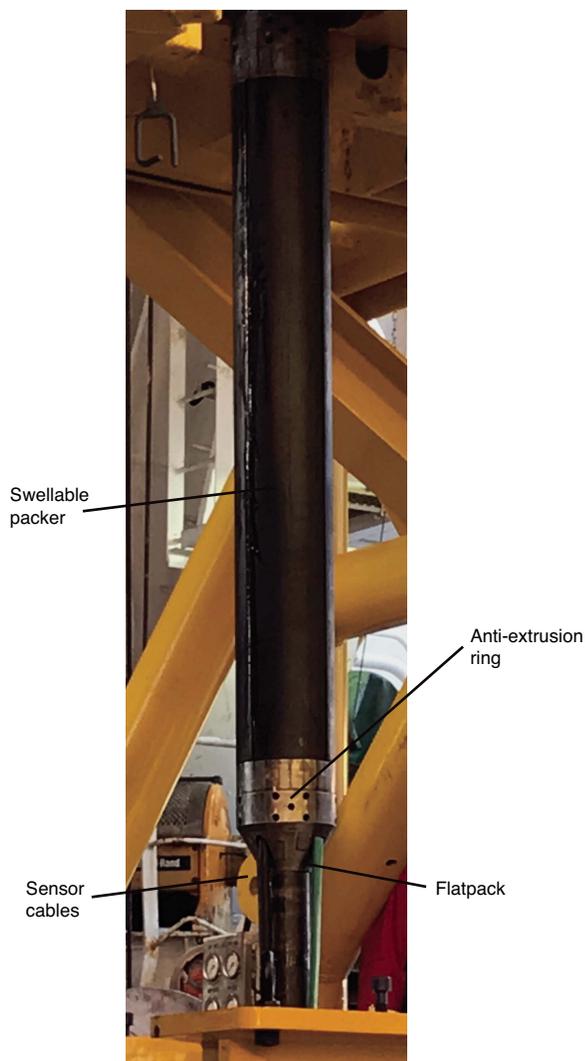
Figure F11. Swellable packer reassembled after passing through the flatpack and sensor cables, Expedition 380.

The swellable packer was attached to the 3.5 inch LTBMS tubing at a position that would correspond to 68 mbsf once deployed downhole in Hole C0006G. A Halliburton engineer inserted the sensor cables and flatpack through the swellable packer (Figure F11). Before passing the sensor cables through the swellable packer, a simple test was performed for all instruments through DMCs.

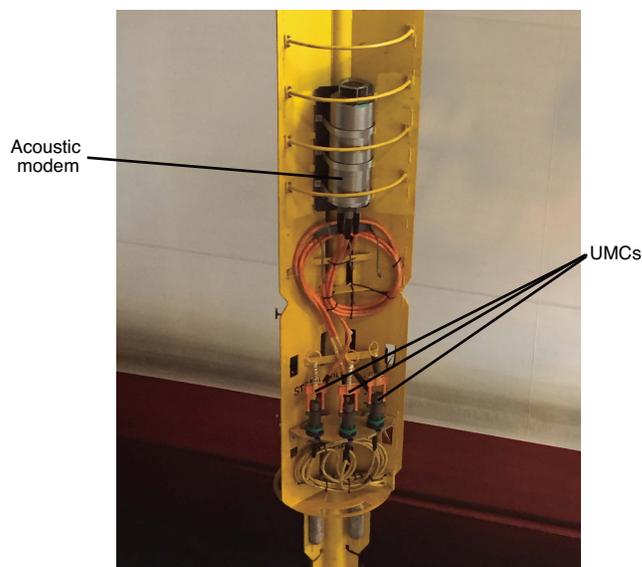
Figure F12. Acoustic modem and UMC cables in LTBMS CORK Bay 2, Expedition 380.

All instruments were then connected to the acoustic modem through UMCs (Figure F12). Once connected, a full test at the moonpool was performed through the modem, which ensured instrument functionality with the acoustic communication system (see Test 18 in *Instrument_tests.xlsx* in CHECKLISTS in [Supplementary material](#) [Becker et al., 2018]). Upon completing the test successfully, the formation and sampling valves were opened to the ocean (hydrostatic pressure) and the LTBMS CORK head was lowered into the water for 5 min to flush the hydraulic tubing with seawater. The LTBMS CORK head was raised, the valves for Pressure Ports 1 and 3 were closed (see Figure F3 in the Expedition 380 methods chapter [Kinoshita et al., 2018]), and the Activation Kit was then attached to the LTBMS. All valves were zip-tied to ensure the handles did not turn during descent.
